Regarding | Spring Channel and Outlet Structure Inspection

Channel from Chisago Lake to Wallmark Lake

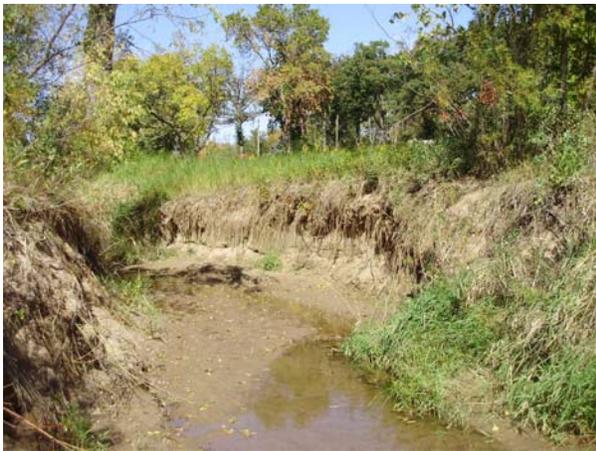
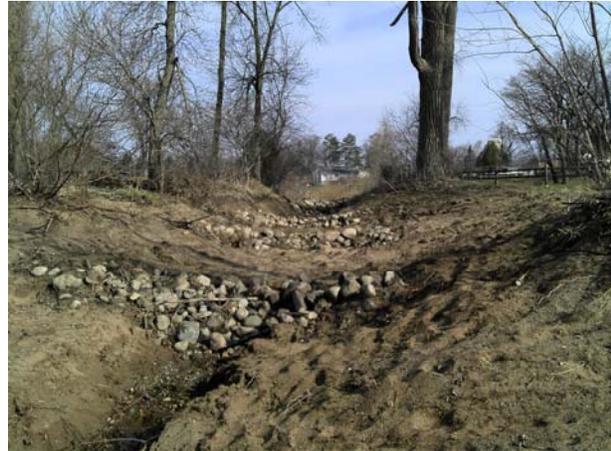
The entire length of the channel from Chisago Lake to Wallmark Lake was walked. Erosion in the channel near the connection with Chisago Lake was noted in previous inspections. Reshaping of this section and installation of rock checks was completed last fall. Final site restoration by the contractor is still needed this spring.

Photos: left-exposed/eroding bank caused by head cut last fall, right- reshaped channel with rock checks

- Proceed with final restoration of channel near Chisago Lake (see punch list provided by EOR).
- Remove debris and logs at the pond outlet
- Remove large branches in channel north of Tot Lot
- Remove downed tree east of Lake Pointe Drive

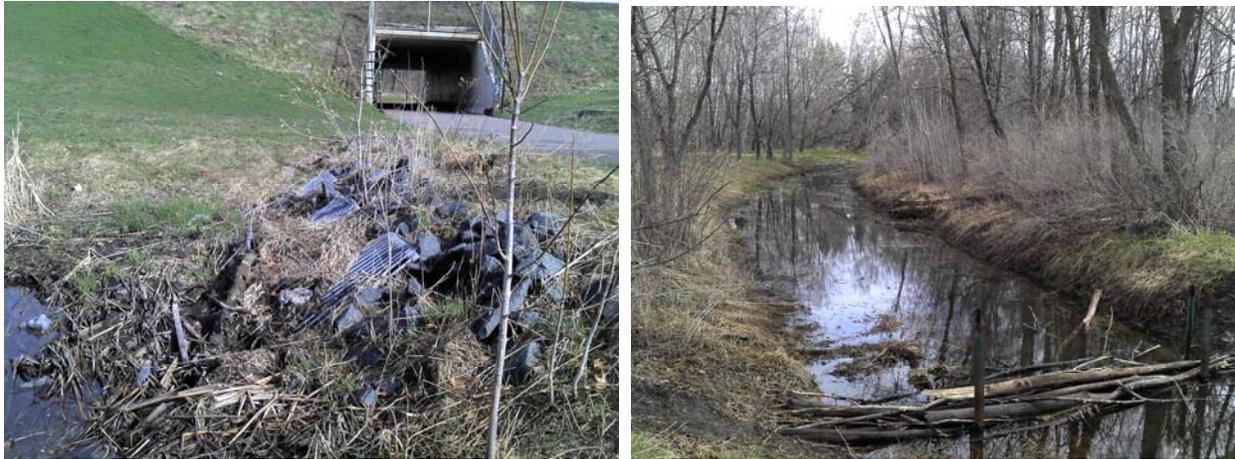
Similar to the last two inspections just North of North Avenue it was noted that several large branches had been placed across the channel to provide a crossing for a path from the nearby tot lot. These logs should be removed. Because this appears to be an ongoing problem the CLLID has directed District Staff to

work with the park owner to determine if a bridge should be placed at this location to allow for crossing the channel without placing obstructions in the channel. Discussions are ongoing. A downed tree was also noted just to the east of where the channel crosses Lake Pointe Drive. The downed tree should also be removed.

Photos: left-rock placed above pipe invert, right-branches placed in channel

- Continue discussions with park owner regarding placement of small foot bridge across the channel.

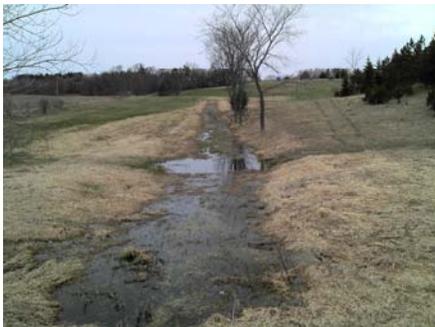
In previous inspections very little water and no noticeable flow was observed in the outlet channel from Wallmark Lake to County Road 19. During this inspection the channel had significantly more water in it and flow was observed. This appears to indicate the Wallmark Lake is outletting. Lake levels are up compared to last year.

- Continue to monitor Wallmark Lake levels relative to the OHW for any indication of obstruction.

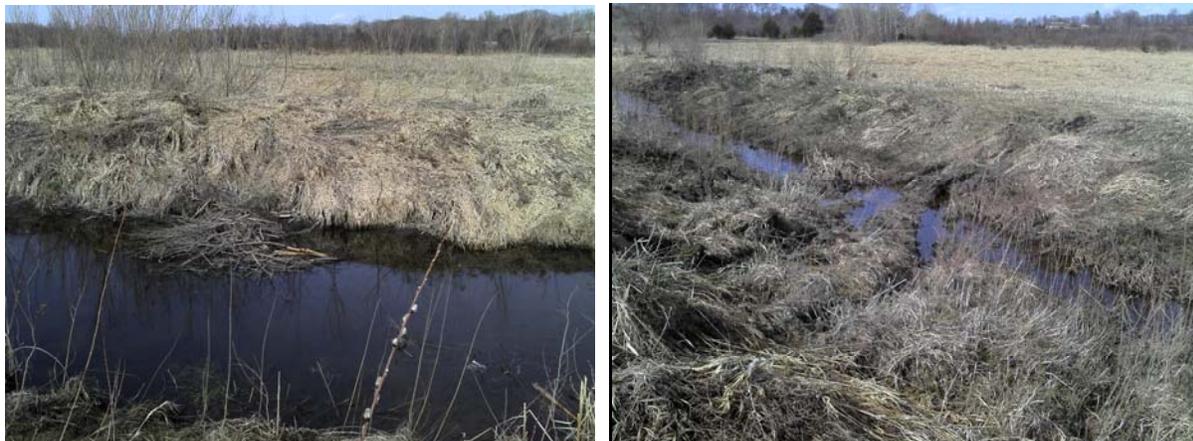
The entire length of the channel from Chisago Lake to Green Lake was walked. Between Chisago Lake and County Road 83 had been a location for frequent beaver activity and dams. The CLLID hired a trapper last year to remove the beavers and the dam was removed by the contractor. No new beaver activity was observed. The large beaver dam midway between County Road 83 and the outlet structure going into Green Lake was also removed last fall. The remnants of a new beaver hut still requires removal. No new beaver activity was noted. Backhoe tracks through the channel were noted and

appeared to have been created during maintenance activities, the contractor needs to clean this area up and remove sediment humps in the channel.

Photos: left-tree down in channel, right - new beaver dam near Chisago Lake

- Remove partial beaver hut from channel
- Remove sediment humps in channel
- Finish site restoration of fall erosion maintenance project (see punch list provided by EOR)

- Continue to monitor for Beaver activity in channel

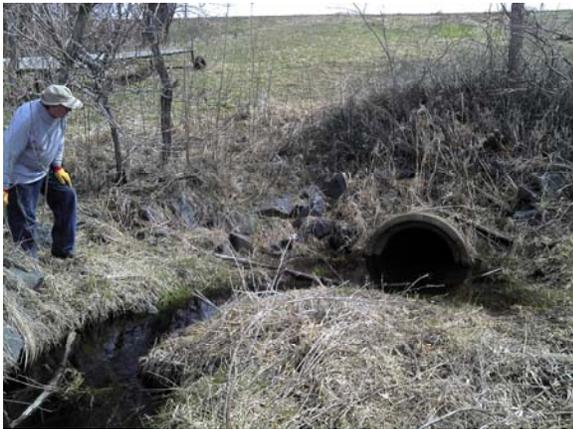
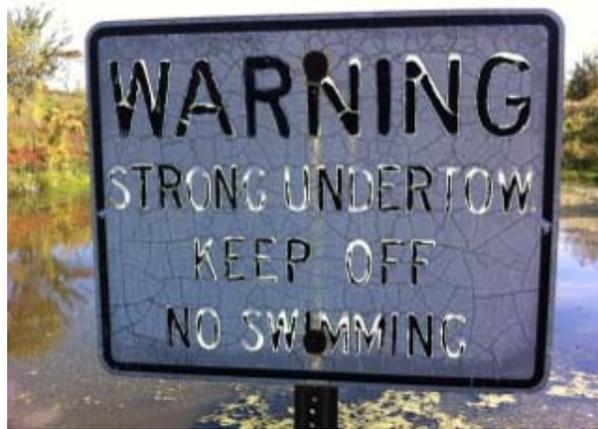
The outlet structure connecting the channel from Chisago Lake to Green Lake was visited. The structure was cleared of debris last fall and everything looked good during the inspections. The gates were opened to test operation and water did flow through the structure to Green Lake. The gates were returned to the closed position upon completion of the inspection.

The undertow sign is in need of replacement. District Staff has the new signs for this weir and the Lake Ellen weir and they will be installed soon.

Photos: left-water flowing from outlet structure into Green Lake, right-faded undertow sign

- Monitor site for continued beaver activity and need for beaver control.
- Replace faded undertow warning sign.

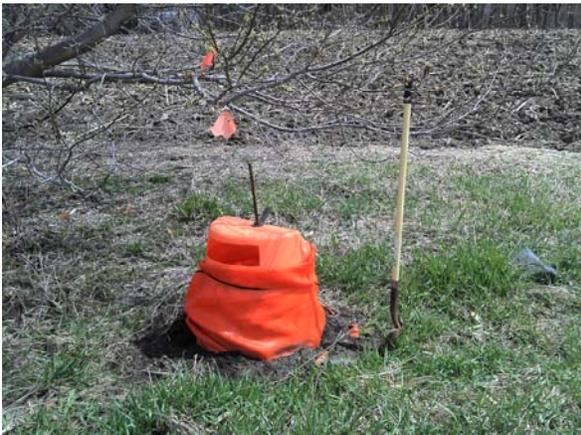
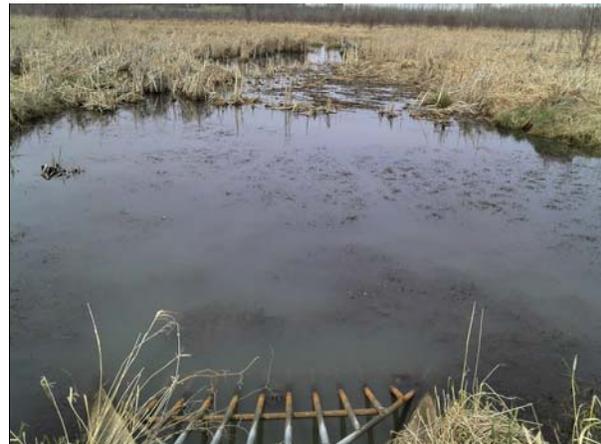
Photos: left-erosion control device installed in farm field, right- outlet to Swamp Lake

Leaving the outlet structure is a long pipe that discharges to Swamp Lake. About a third of the way downstream is a manhole with an inlet structure that is located in the middle of the farm field. It was recommended previously that a sediment control device or structure modifications be located above or around this structure to limit sediment into pipe. The erosion control device was installed last fall and appears to have been effective through the spring melt. The down stream end of the pipe is partially submerged and the water at the outlet was less cloudy then previously observed.

- Monitor Beaver Activity going forward and determine need for additional beaver control.
- Periodically exercise the gates to maintain them in working order.
- Engineer to obtain and review plans and make recommendation for dewatering pipe prior to televising, if maintenance at Swamp Lake outlet does not sufficiently lower water levels.
- Replace undertow warning sign similar to Lofton Avenue wier.

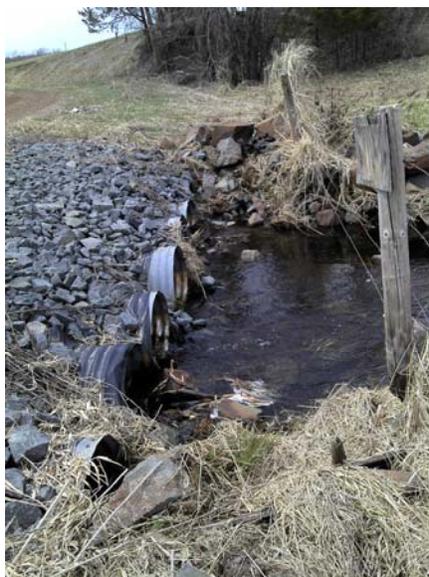
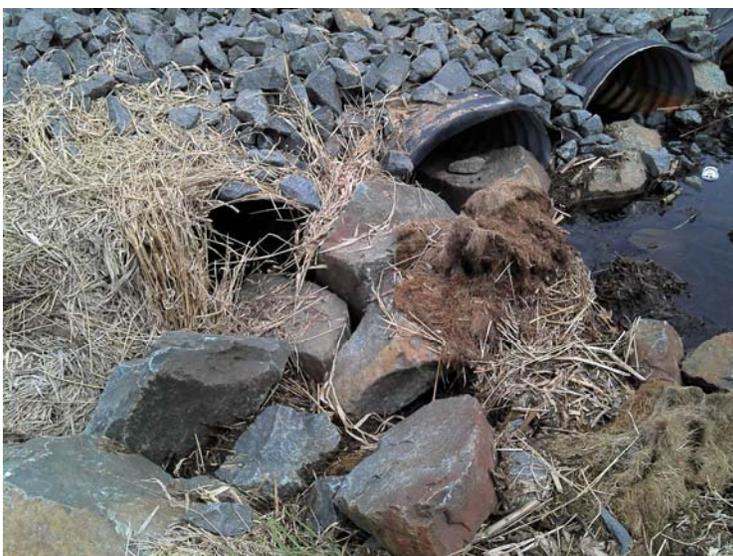
The Swamp Lake outlet pipes under County Road 80 were visited. This location has 7 pipes under the road to convey flow. Water was flowing at the time of the inspection. In previous inspection the pipes were partially filled with water due to rock and debris just downstream of the culverts that appeared to be obstructing some of the flow causing tailwater on the pipes. The obstruction has for the most part been removed by the contractor and water is free flowing through 5 of the 7 pipe. Addition clean out around the two outermost pipe is recommended.

Photos: Outlet End of pipes leaving Swamp Lake

- Additional Minor clean-out at outlet end of pipes and reconfigure rip rap.

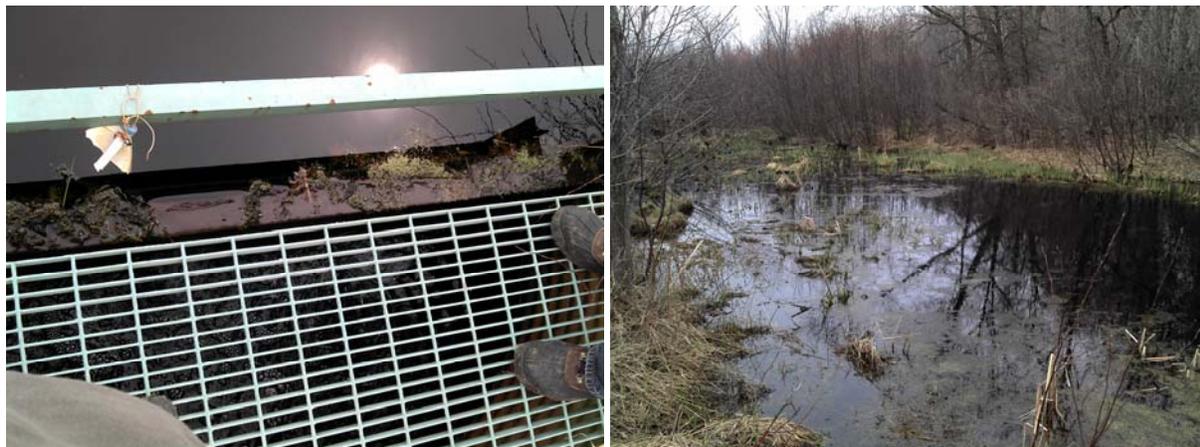
The culvert crossing under Ivywood Trail was visited. It was thought that this structure does not provide any conveyance due to the outlet channel to Carlos Avery WMA never being completed. However, water was flowing through the Ivywood crossing during the inspection and it appeared that water may be making its way back through a wooded swamp and possibly into Carlos Avery.

- Get direction from the Board on whether to investigate whether there is a connection to Carlos Avery.

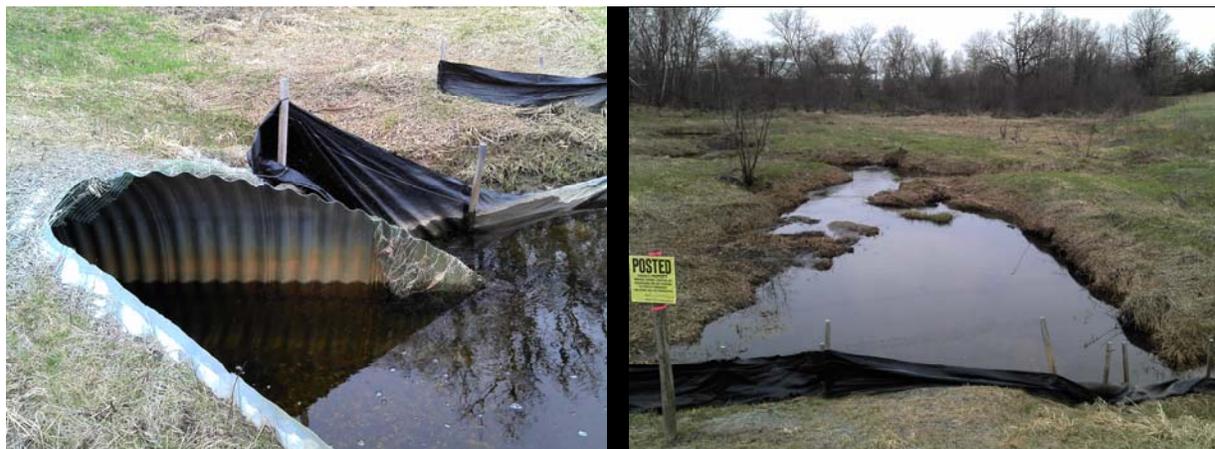
The Bloomquist Creek Crossing at Ivywood Trail was visited. A new culvert had recently been installed at this location. Water was flowing through the stream and no maintenance issues were noted. The Bloomquist Creek Crossing at County Road 19 was also visited and water was flowing at this location also. The upstream end of the pipe was submerged as noted in the previous inspection report. It was unclear why the upstream end of this culvert was submerged however water appeared to be flowing freely. Beaver dams both north and south of County Road 19 were previously reported by a landowner to District staff. It appeared that the beaver dams had been remove and water levels had dropped. No obstructions were noted. No Action Needed

Photos: Bloomquist Creek Crossing @ Ivywood
