**Date** | 6-7-2010

**From** | Dan Fabian & Greg Graske

**Regarding** | 5/21/2010 Channel and Outlet Structure Inspection

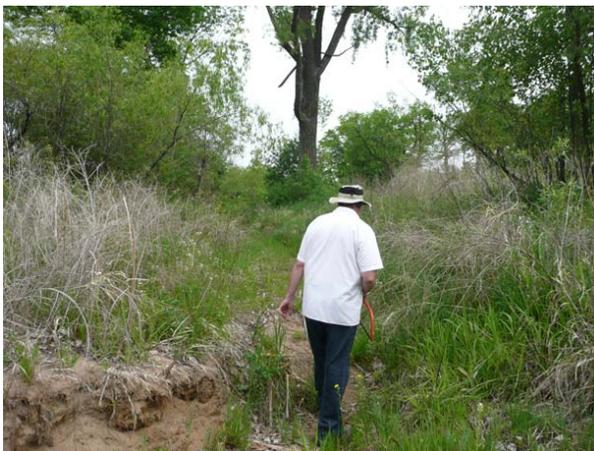
The entire length of the channel from Chisago Lake to Wallmark Lake was walked. Erosion was noted in the channel near the connection with Chisago Lake. This was being caused by head cutting of the channel that is a result of a combination of factors including stormwater flows towards Chisago Lake and the lake level being down several feet. Some rock has been placed in the channel in an attempt to stop this erosion. Additional strategic placement of rock may be warranted for better protection of this channel. Also near the connection with Chisago Lake a downed tree is obstructing the channel and should be removed.

Photos: left-exposed/eroding bank caused by head cut, right-deadfall in channel

- Remove fallen tree from channel near Chisago Lake channel connection.
- Rearrange rip rap at box culvert outlet such that it is not obstructing upstream flows.

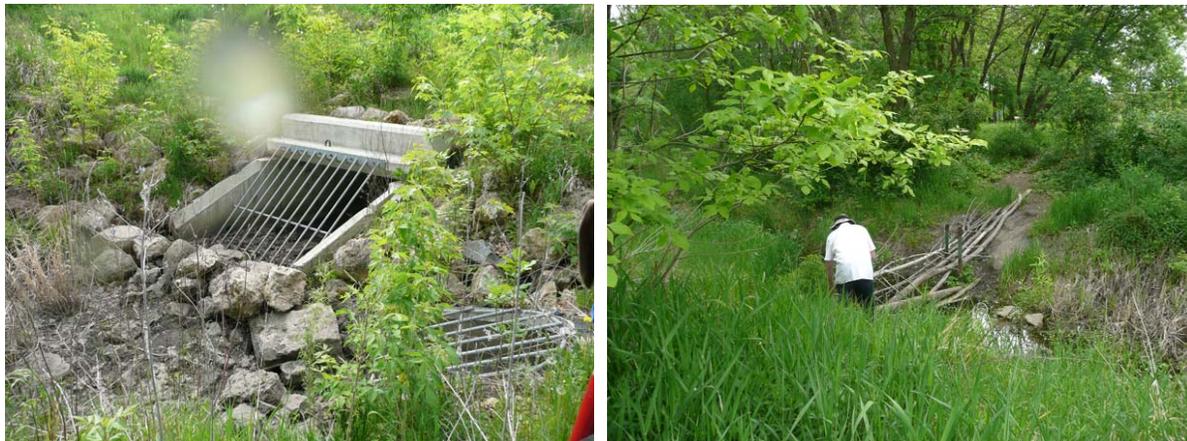
Just downstream of these areas is a large box culvert that flows under Stinson Avenue and Highway 8. At the down stream end of this pipe some of the large rock placed for erosion control purposes is currently sitting above the invert of the pipe. This may be obstructing some of the flows from upstream. The

landowner at the upstream end of the box culvert is concerned about water levels and stormwater flowing towards Chisago Lake that he feels should be flowing out towards Wallmark Lake. Removal of this rock and further investigation of drainage in this area is warranted.

North of North Avenue it was noted that several large branches had been placed across the channel to provide a crossing for a path from the nearby tot lot. It is our understanding that at one-time there was a small foot-bridge at this location. The branches were removed from the channel as has been done on previous inspections. Because this appears to be an ongoing problem the LID may want to consider a more long term solution. One option that could be considered is placement of a small foot-bridge at this location to allow for crossing the channel without placing obstructions in the channel.

Photos: left-rock placed above pipe invert, right-branches placed in channel

- Survey of channel upstream and downstream of box culvert to determine if there is positive grade and determine if there are obstructions causing flow toward Chisago Lake instead of out to Wallmark Lake as observed by landowner. Compare survey against project as-built plans.
- Have Engineer develop sketch plans to address erosion of channel into Chisago Lake, develop preliminary cost estimate and bring back to Board for consideration.
- Board should discuss pros and cons of placing a bridge at the make shift crossing site currently being used to cross the channel. If Board feels a small foot-bridge is appropriate then staff should be directed to work with park (tot lot) owner on bridge design, installation and maintenance. We suggest LID consider providing cost share funding with park owner being responsible for installation and on-going maintenance.

- Removed branches placed in channel
- Lopped off small trees growing on overflow weir control structure

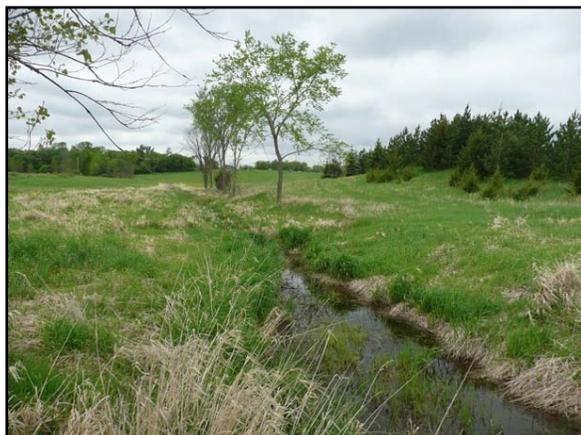
The crossing at County Road 19 was visited. A small amount of stagnant water was noted in the small grass channel. Flow was not observed. No maintenance issues were noted.

- Next quarterly inspection walk the entire channel and investigate the connection at the Wallmark Lake outlet.

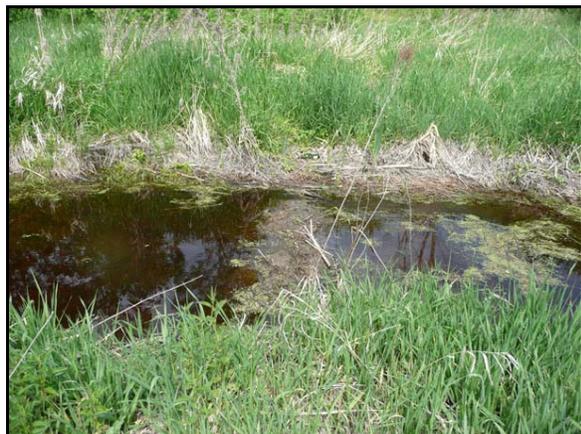
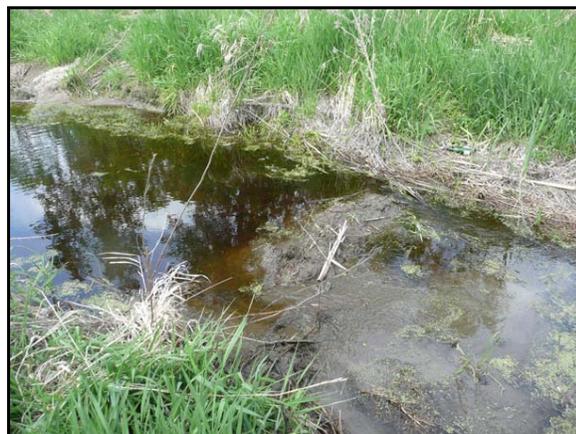
The entire length of the channel from Chisago Lake to Green Lake was walked. Between Chisago Lake and County Road 83 a small sediment hump was observed and was likely the beginning of a beaver dam. At the time of the visit this sediment hump was only holding back a couple inches of water. This hump was breached during the site visit.

Photos: left sediment hump before breach, right sediment hump after breach

- Engineer to visit erosion site to take measurements, develop sketch plans, preliminary cost estimate and bring back to Board for consideration.
- Recheck small sediment hump during future inspections to determine additional Beaver activity and need for removal.

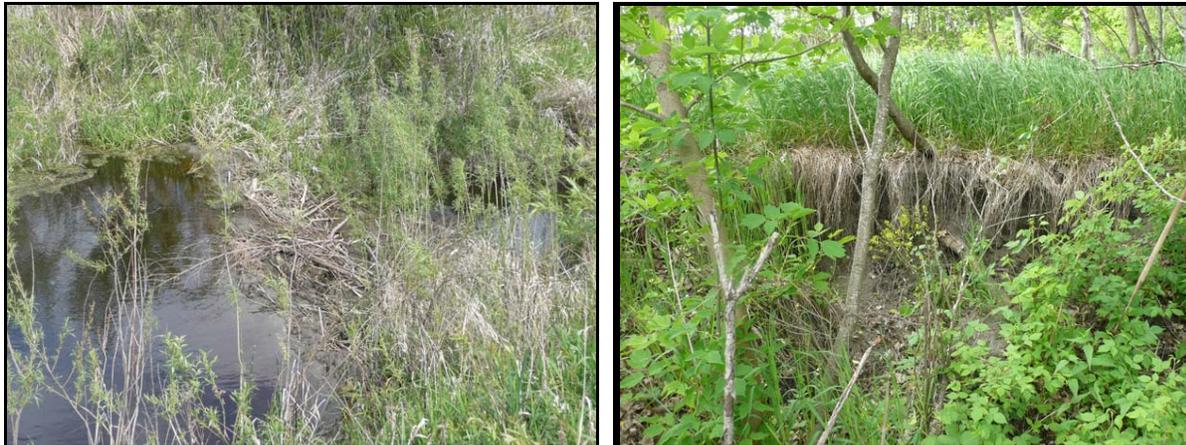
About midway between County Road 83 and the outlet structure going into Green Lake a large beaver dam was observed this dam was holding back approximately 2 feet of water.

Photos: left-large beaver dam, right erosion near channel bank

Further down the channel significant erosion was noted up on the bank of the channel. The erosion appeared to be caused by runoff from the adjacent farm field concentrating at the location of erosion. Although it did not appear that the sediment is making it all the way down to the channel bottom, it is recommended that this area be stabilized before this starts to occur. Strategic placement of rock and plantings could be used to stop the erosion

- Remove large Beaver Dam. Remove beaver prior to removal of beaver dam. Engineer to get contact information for beaver trapper.

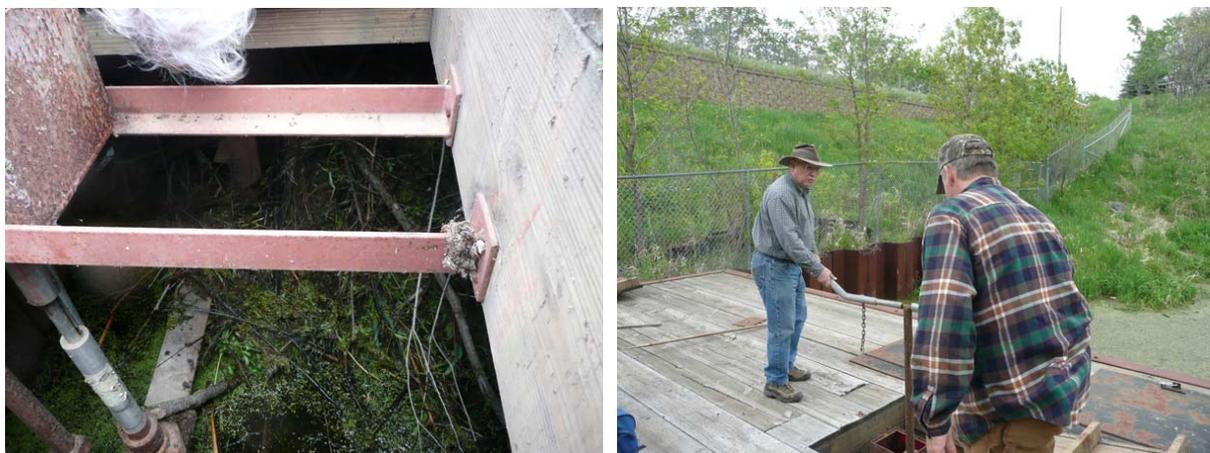
The outlet structure connecting the channel from Chisago Lake to Green Lake was visited. Branches were noted that appeared to be placed inside the weir structure by a beaver. Jerry Spetzman performed some minor maintenance items that are noted below subsequent to the inspection.

Photos: left-Branches inside of control structure, right-Testing operation of gates

- Remove branches from overflow weir.

- Periodically exercise the gates to maintain them in working order.
- Purchase or have another tool made for operating the control gates (currently there is only one tool between the two control structures). Engineer to obtain and review original project specifications for gate model, recommended maintenance practices and check on availability of a portable motorized tool for operating gates.
- Monitor site for continued beaver activity and need for beaver control.
- Replace faded undertow warning sign.

- Cleaned out the mouse nests in the crank boxes.
- Greased three grease fittings in each of the crank boxes.
- Hammered in all high nails.
- Oiled all locks.
- Replaced broken hasp lock

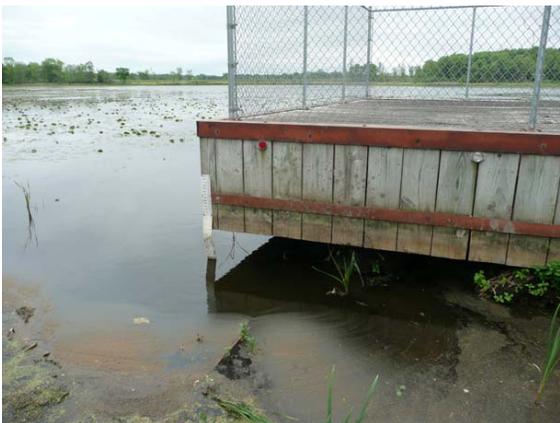
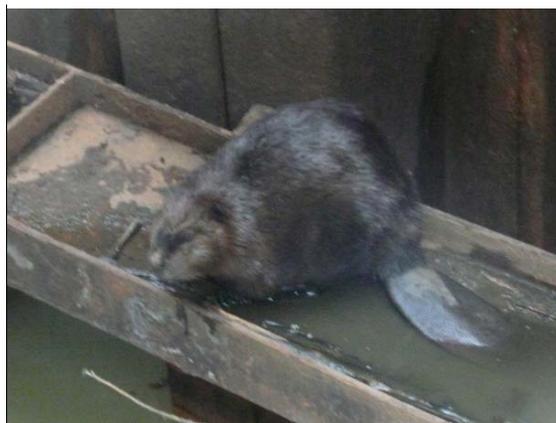
The outlet structure on Lake Ellen was visited. Debris was currently in the process of being removed from around the Lake Ellen structure. It was clear from the site visit that a beaver had decided to make the structure his home. A beaver was observed inside of the structure. The outlet gate was partially open when the site was visited. No water was flowing over the sheet pile weir. The gate was closed during the site visit. The emergency management plan calls for the gate to be open when the lake level is 891.5. The plan also says that the gate may remain closed when lake levels are below 891.0. Lake Ellen was at elevation 889.4 on 5/26/2010 per monitoring report. Continue to monitor lake levels and open gates when water levels start to increase. Jerry Spetzman performed some minor maintenance items that are noted below subsequent to the inspection.

Photos: left-Outlet control structure, right- Beaver inside of outlet structure

- Proceed with televising pipe.
- Engineer to obtain and review plans and make recommendation for dewatering pipe prior to televising, if maintenance at Swamp Lake outlet does not sufficiently lower water levels.
- Remove beaver at Ellen Lake weir.

- Monitor Beaver Activity going forward and determine need for additional beaver control if beaver debris build-up continues to be a major problem at this location.
- Determine whether the gate should remain in the closed position until water levels start to rise on the lakes again. Engineer to review operation plan and make recommendation.
- Periodically exercise the gates to maintain them in working order.
- Purchase or have another tool made for operating the control gates (currently there is only one tool between the two control structures). Engineer to obtain tool cost information and also explore availability of powered tool for operating gates.
- Engineer will explore sediment control options and costs at pipe inlet in farm field and provide recommendation to Board.

- Cleaned out the mouse nests in the crank boxes.
- Greased three grease fittings in each of the crank boxes.
- Hammered in all high nails.
- Oiled all locks.

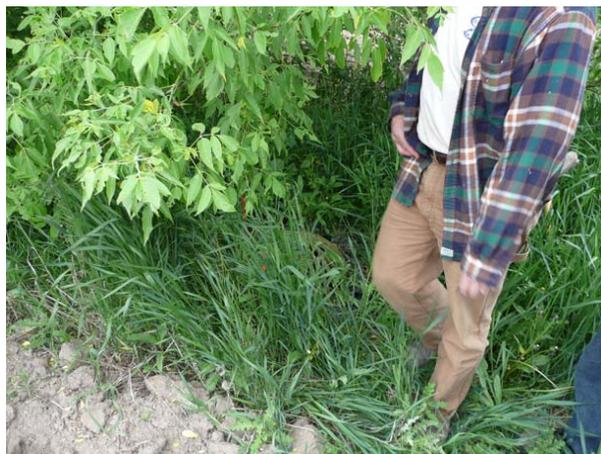
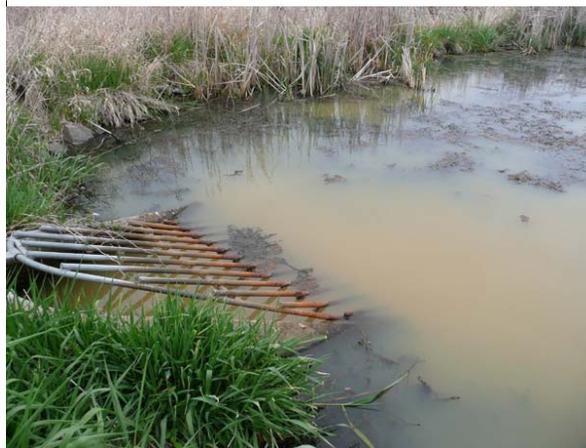
Leaving the outlet structure is a long pipe that discharges to Swamp Lake. About a third of the way downstream is a manhole with an inlet structure that is located in the middle of the farm field. There is some concern that sediment from this farm field may be entering the pipe. It is recommended that a sediment control device or structure modifications be located above or around this structure to limit sediment into pipe. The down stream end of the pipe is partially submerged and the water at the outlet was cloudy. It was unclear what was causing the murkiness in the water. Televising the pipe has been proposed and it is recommended that this occur when possible. It may be possible to sand bag the end of

the pipe and dewater in order to get the camera inside of the pipe. Maintenance at the downstream end of Swamp Lake (see Swamp Lake of report) may also help with lowering water levels.

Photos: left-Beehive Inlet above Lake Ellen outlet pipe, right- Outlet pipe into Swamp Lake

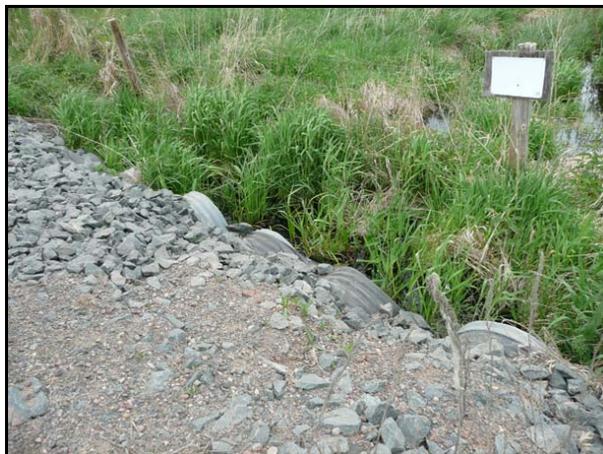
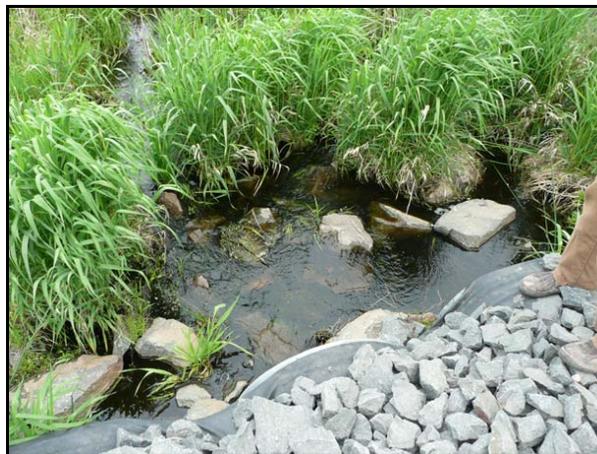
The Swamp Lake outlet pipes under County Road 80 were visited. This location has 7 pipes under the road to convey flow. Water was flowing at the time of the inspection. The pipes were partially filled with water due to rock and debris just downstream of the culverts that appeared to be obstructing some of the flow causing tailwater on the pipes. The water drop across the obstruction was estimated at about half a foot.

Photos: Outlet End of pipes leaving Swamp Lake

- Minor clean-out at outlet end of pipes and reconfigure rip rap.

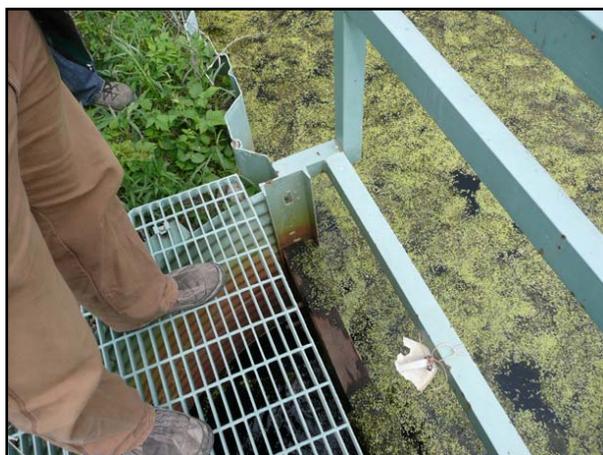
The culvert crossing under Ivywood Trail was visited. The previous inspection report indicated that the stop logs had been removed and were sitting adjacent to the structure. The stop logs have subsequently been replaced. This culvert crossing only serves as an equalizer under the road as the outlet channel to the west was never finished.

No Action Needed.

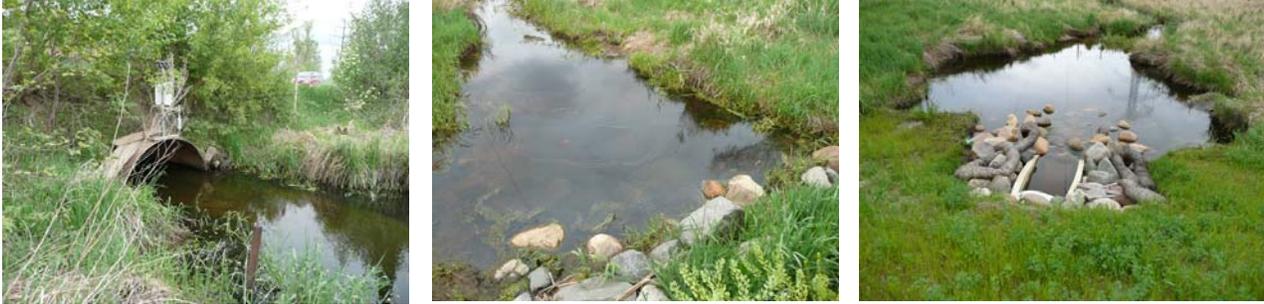
The Bloomquist Creek Crossing at Ivywood Trail was visited. Water was flowing through the stream and no maintenance issues were noted. The Bloomquist Creek Crossing at County Road 19 was also visited and water was flowing at this location also. The upstream end of the pipe was completely submerged, while the downstream end only had a couple inches of water actively flowing through it. It was unclear why the upstream end of this culvert was submerged and further investigation is warranted.

Photos: Left-Bloomquist Creek Crossing @ Ivywood, Center-Upstream end of Bloomquist creek crossing @ CR 19, Right-Downstream end of crossing @ CR 19

- Engineer to obtain plans for County Road 19 crossing to determine original design.
- Engineer to make recommendations for further action depending on the outcome of the design plan review.
