**Date** | 11-29-2011

**To** | Chisago Lakes LID Board of Managers

**From** | Greg Graske

**Regarding** | Summer Channel and Outlet Structure Inspection

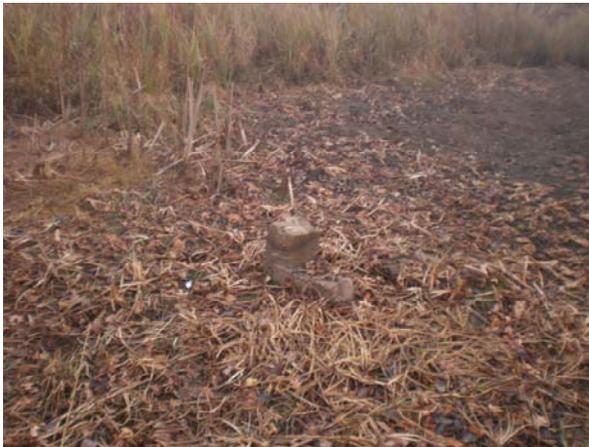
The length of the channel from Chisago Lake to Wallmark Lake was inspected. The channel area near Stinson Avenue was dry at the time of the inspection. Some concrete blocks were noted on the bottom of the pond near the outlet under Stinson Avenue. These blocks could easily be removed with the channel being drier than usual.

Photos: left, concrete block in bottom of the area near Stinson Avenue, right- branches placed across channel

- Remove concrete blocks near Stinson Avenue Crossing
- Remove branches in chanell near tot lot
- Remove debris at Sportsman Drive culvert
- Remove downed tree across trail east of the Lake Point Drive crossing

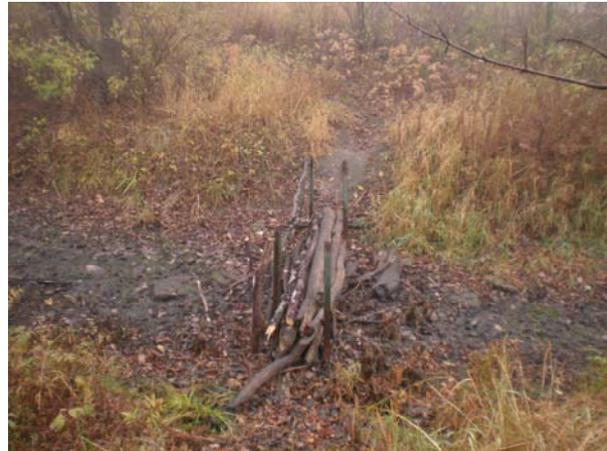
Similar to previous inspections just North of North Avenue it was noted that several large branches had been placed across the channel to provide a crossing for a path from the nearby tot lot. These logs should be removed. Because this appears to be an ongoing problem the CLLID has directed District Staff to work with the park owner to determine if a bridge should be place at this location to allow for crossing the channel without placing obstructions in the channel. Discussions are ongoing.

- Continue efforts regarding placement of small foot bridge across the channel.

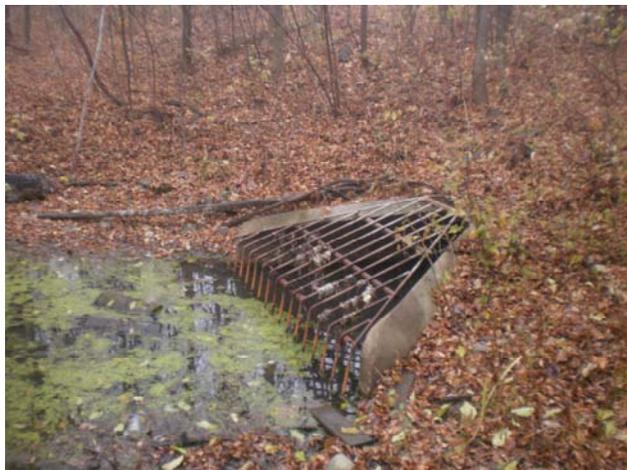
Debris was noted at the Sportsman Drive Crossing. This debris should be removed. A downed tree was noted on the trail east of the Lake Point Drive crossing. Although not impeding flows this could be removed in conjunction with the rest of the maintenance efforts in this area.

Photos: debris at Sportsman Drive culvert

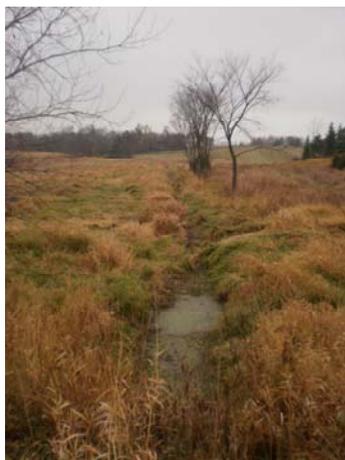
No flow was occurring at the time of inspection. No concerns were noted.

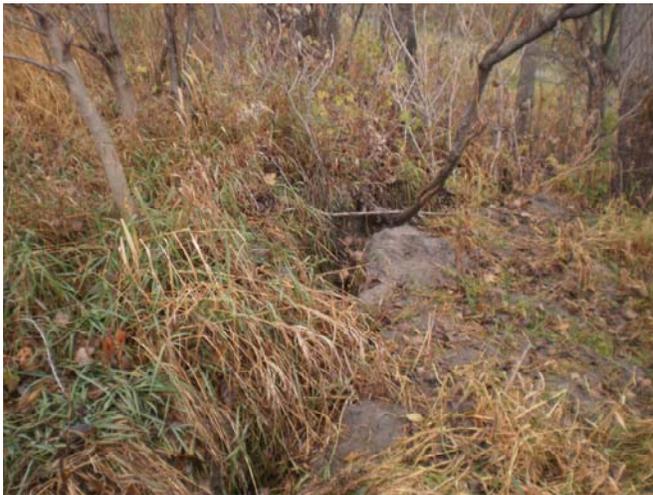
Last fall some erosion areas from flow being delivered off the adjacent farm field were repaired by the contractor. One of the areas is holding up well, while the other area is starting to see some of the erosion return. Follow up repairs are recommended to prevent future erosion and sediment transport into the channel.

Photos: Erosion cause by flow from adjacent farm field

- Follow up corrective action at erosion site

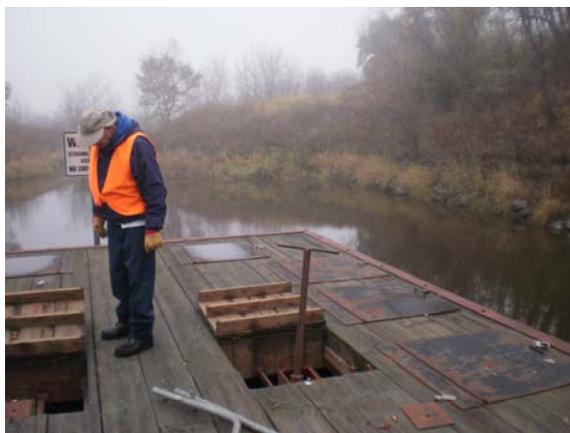
The outlet structure connecting the channel from Chisago Lake to Green Lake was visited. The structure was cleared of debris last fall and everything looked good during the inspections. The gates were opened to test operation and water did flow through the structure to Green Lake. The gates were returned to the closed position upon completion of the inspection.

Photos: left-operating the outlet gate to Green Lake

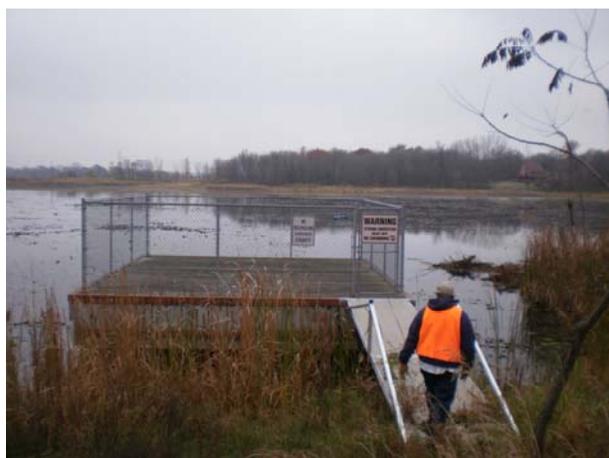
The outlet structure on Lake Ellen was visited. Debris was removed from around the Lake Ellen structure last year. The gate was exercised and appeared to be operational. The emergency management plan calls for the gate to be open when the lake level is 891.5. The plan also says that the gate may remain closed when lake levels are below 891.0. Lake Ellen was below the weir overflow elevation; therefore the gate was left closed. No new beaver activity was observed.

Photo: Lake Ellen weir

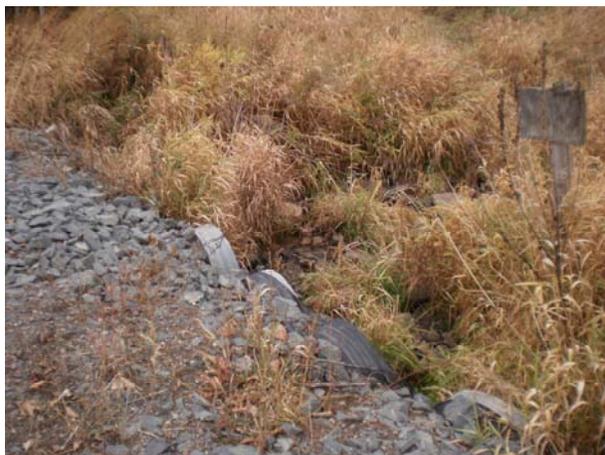
The Swamp Lake outlet pipes under County Road 80 were visited. This location has 7 pipes under the road to convey flow. Water was flowing at the time of the inspection. In previous inspections the pipes were partially filled with water due to rock and debris just downstream of the culverts that appeared to be obstructing some of the flow causing tailwater on the pipes. The obstruction has been removed by the contractor and water is free flowing through the pipes.

Photos: Pipes leaving Swamp Lake

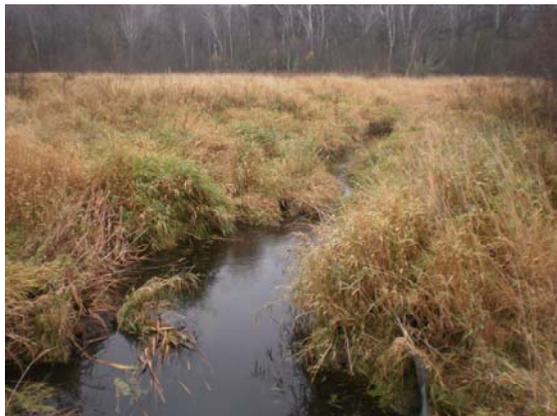
The Bloomquist Creek Crossing at Ivywood Trail was visited. A new culvert had recently been installed at this location. Water was flowing through the stream and no maintenance issues were noted. The Bloomquist Creek Crossing at County Road 19 was also visited and water was flowing at this location also.

Photos: Bloomquist Creek at Ivywood Trail
