**Date** | 9-9-2011

**To** | Chisago Lakes LID Board of Managers

**Regarding** | Summer Channel and Outlet Structure Inspection

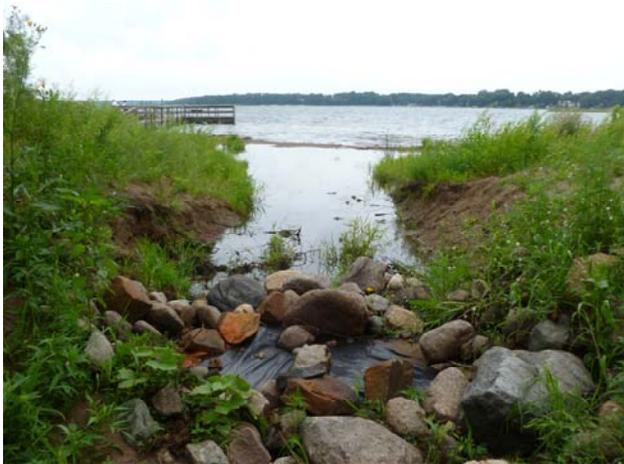
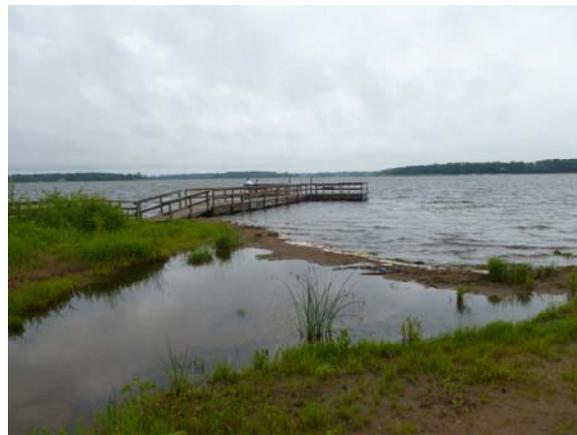
The length of the channel from Chisago Lake to Wallmark Lake was inspected. Erosion in the channel near the connection with Chisago Lake was noted in previous inspections. Reshaping of this section and installation of rock checks was completed last fall. It appears that someone (likely kids) have been moving rocks from the lower check dams to the beach. Repair of these check dams with larger rock is recommended to limit the ability for the rocks to be moved.

Photos: lower check dam, right- rocks moved out to the beach area

- Repair of lower check dam near Chisago Outlet with larger rock

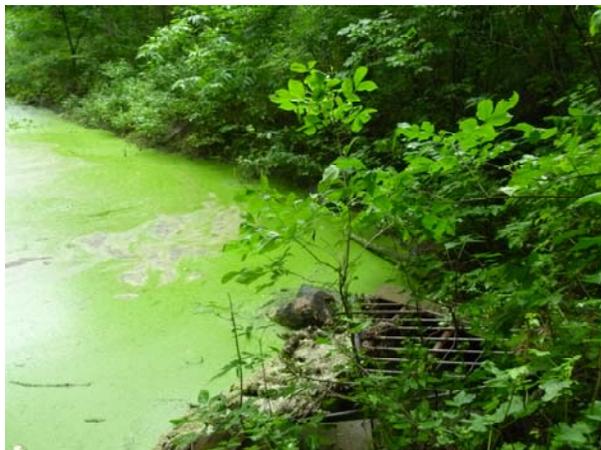
this location to allow for crossing the channel without placing obstructions in the channel. Discussions are ongoing. Debris was noted at the Sportsman Drive Crossing. This debris was cleared at the time of the inspection.

Photos: debris at sportsman drive culvert

- Removed debris at Sportsman Drive

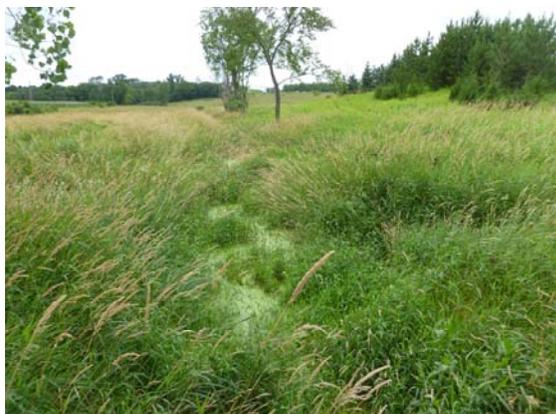
Last year very little water and no noticeable flow was observed in the outlet channel from Wallmark Lake to County Road 19. During this inspection and the spring inspection the channel had water in it and flow was observed. This appears to indicate the Wallmark Lake is outletting. Lake levels are up compared to last year.

- Continue to monitor Wallmark Lake levels relative to the OHW for any indication of obstruction.

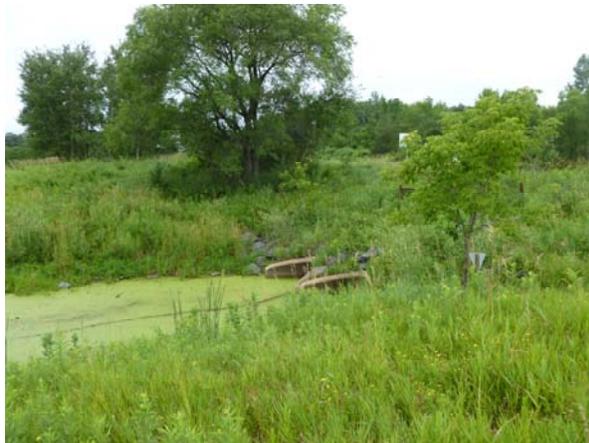
remove the beavers and the dam was removed by the contractor. No new beaver activity was observed.

Photos: Culverts under Chisago Blvd

- Continue to monitor for Beaver activity in channel

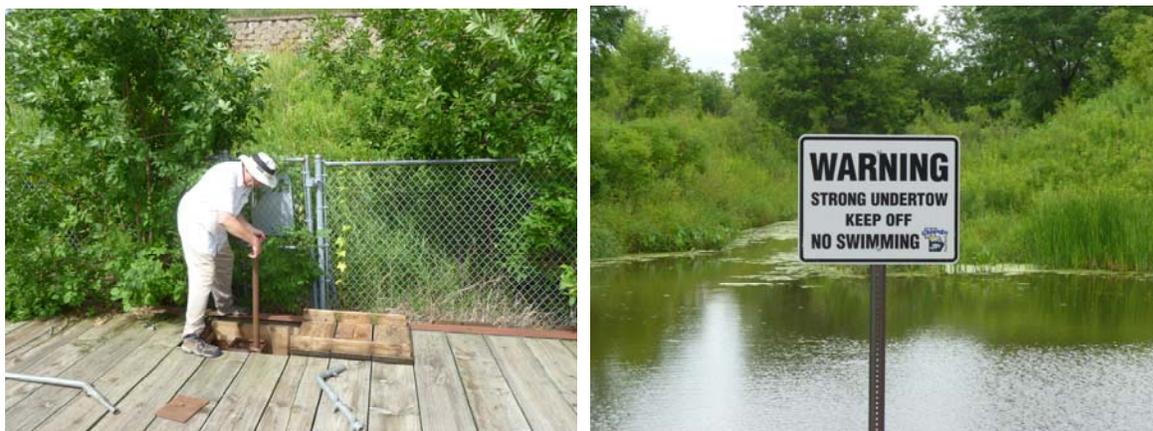
The outlet structure connecting the channel from Chisago Lake to Green Lake was visited. The structure was cleared of debris last fall and everything looked good during the inspections. The gates were opened to test operation and water did flow through the structure to Green Lake. The gates were returned to the closed position upon completion of the inspection.

The undertow sign was previously noted as needing replacement. District Staff has since replaced the undertow sign.

Photos: left-operating the outlet gate, right-new undertow warning sign

- Greased the fittings in each of the crank boxes.
- Tested Gate Operation

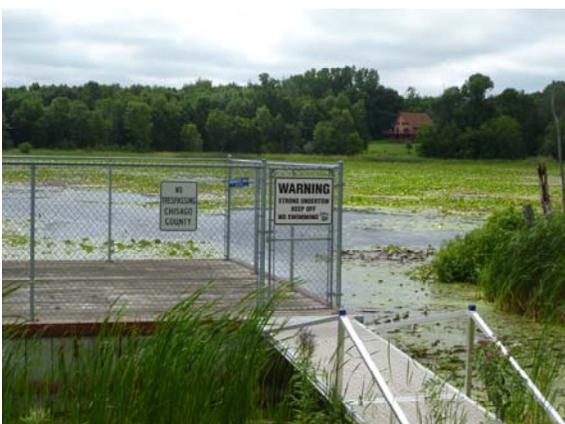
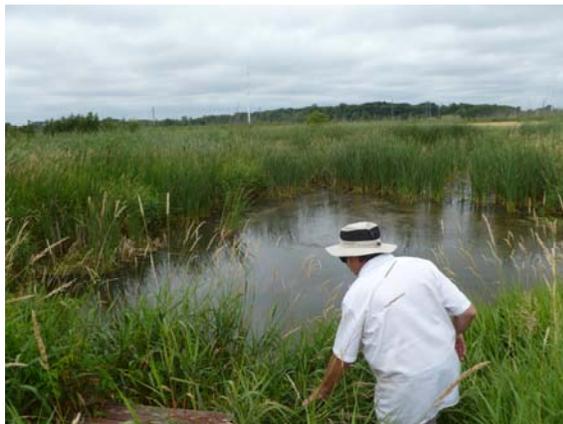
The outlet structure on Lake Ellen was visited. Debris was removed from around the Lake Ellen structure last year. The gate was exercised and appeared to be operational. The emergency management plan calls for the gate to be open when the lake level is 891.5. The plan also says that the gate may remain closed when lake levels are below 891.0. Lake Ellen was below the weir overflow elevation; therefore the gate was left closed. No new beaver activity was observed.

Photos: left-Lake Ellen weir, right- outlet to Swamp Lake

In previous inspections the water flowing out of the outlet has been clouded with sediment. At this inspection the water was clear. This may be due to the installation of the silt cover over the erosion control device in the farm field.

- Greased the fittings in each of the crank boxes.
- Exercised Gate

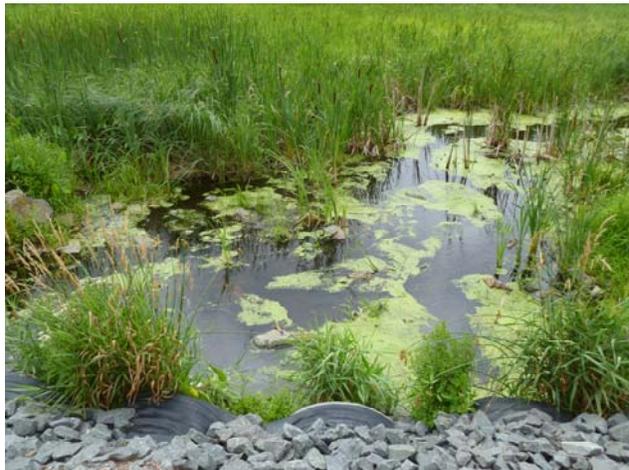
The Swamp Lake outlet pipes under County Road 80 were visited. This location has 7 pipes under the road to convey flow. Water was flowing at the time of the inspection. In previous inspections the pipes were partially filled with water due to rock and debris just downstream of

the culverts that appeared to be obstructing some of the flow causing tailwater on the pipes. The obstruction has been removed by the contractor and water is free flowing through the pipes.

Photos: Pipes leaving Swamp Lake

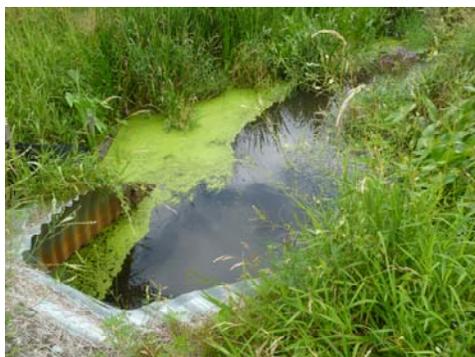
The Bloomquist Creek Crossing at Ivywood Trail was visited. A new culvert had recently been installed at this location. Water was flowing through the stream and no maintenance issues were noted. The Bloomquist Creek Crossing at County Road 19 was also visited and water was flowing at this location also.

Photos: Bloomquist Creek Crossing @ Ivywood
