Date | 6-30-2014

To | Chisago Lakes LID Board of Managers

Regarding | Spring Channel and Outlet Structure Inspection

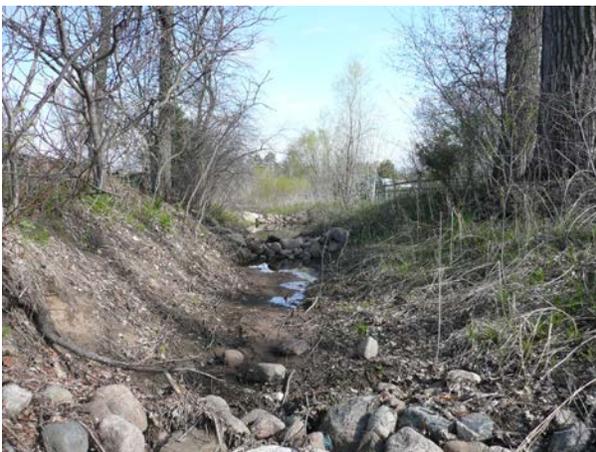
The channel from Chisago Lake to Wallmark Lake was inspected. The channel area near Stinson Avenue appeared to be stable and the existing rock check dam appears to be eliminating any further head cutting and erosion of the channel. The trees along the channel section between Highway 8 and North Avenue were cleared two years ago. No issues were noted.

Photos: Left: check dams, Right: Cleared Channel

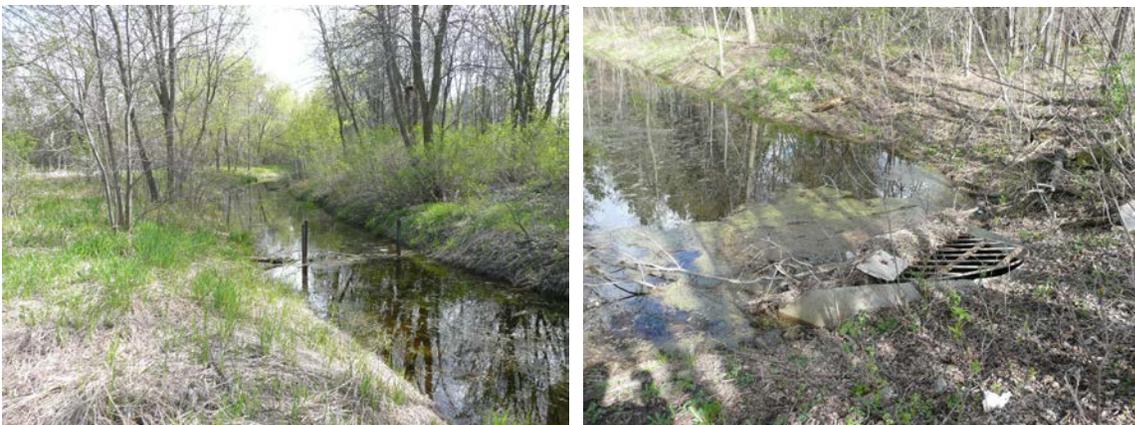
Debris including branches, logs, and trash were noted in the section between Sportsmans Drive and North Avenue. It is recommended that this debris be removed. At the time of the inspection the debris was removed from the upstream end of the trash rack on the culvert under Sportsmans Drive.

Photos: debris between North Avenue and Sportsman Drive

- Remove debris in channel between North Avenue and Sportsman Drive

- Debris Cleared from Sportsman Drive culvert trash rack

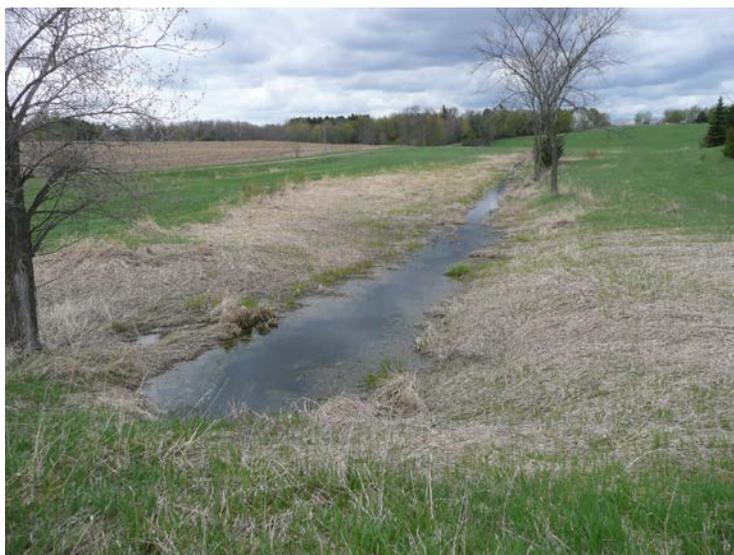
Photo: Channel south of County Road 19

The channel is currently flowing indicating that water is discharging from Wallmark Lake. No concerns were noted.

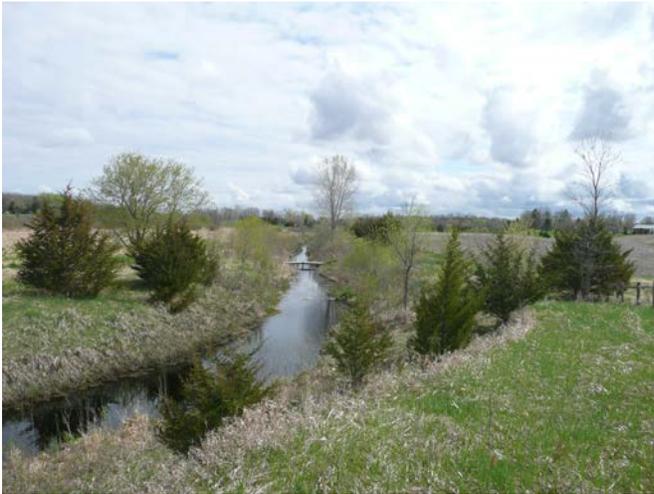
Photo: head cut in channel near Chisago Lake

The channel was free of debris. No issues noted.

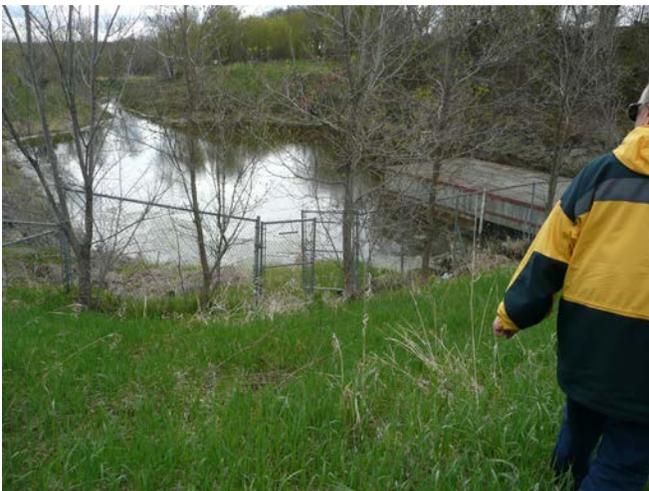
Photos: Outlet Structure

The outlet structure connecting the channel from Chisago Lake to Green Lake was visited. Several repairs were made to the structures in 2012. These repairs included fixing one of the gates, fixing the fence, and repairing a leak. The gates were tested and were working correctly. Water was observed flowing from the wetland area to Green Lake when opened. The gates were returned to the closed position upon completion of the inspection. One of the gates on the fence was open at the time of the inspection. This gate was closed, however a new lock needs to be installed. It is also recommended that a lift handle be installed on the access hatch to ease opening when the wood is swollen due to moisture.

- Install new lock on fence gate
- Install lift handle on access hatch

- Monitor site for continued beaver activity and need for beaver control.

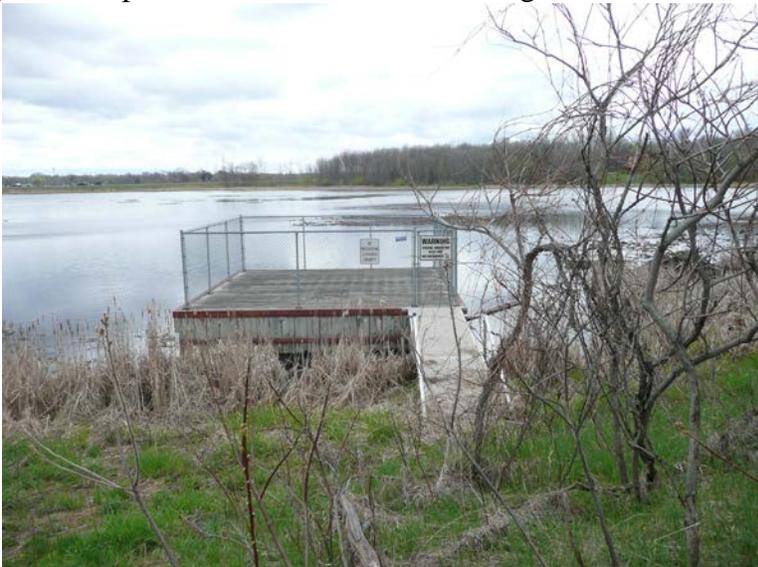
Photo: Lake Ellen Outlet Structure

A repair to the gate mechanism, clearing of vegetation and replacement of the missing control box cover was completed in 2012. The gate was exercised and appeared to be operational. The gate was opened on June 27th due to rising water levels on Green Lake.

- Monitor Erosion Control Device in farm field for needed maintenance
- Perform Monthly inspections while water is flowing through the outlet

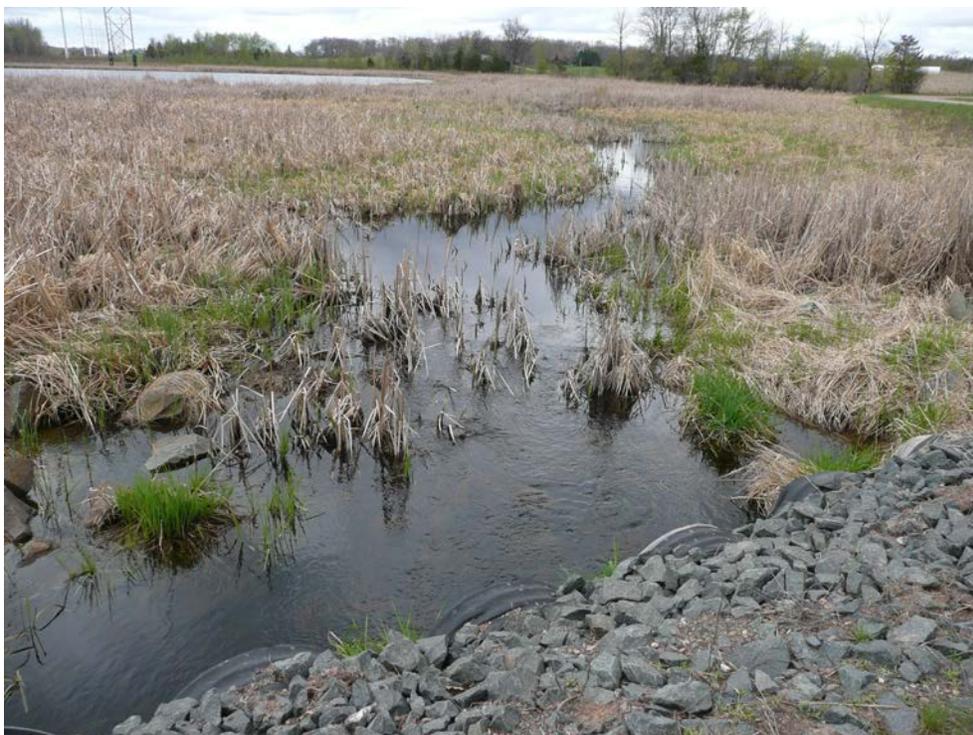
The Swamp Lake outlet pipes under County Road 80 were visited. This location has 7 pipes under the road to convey flow. Obstructions previously noted have been removed. No concerns were noted.

Photos: Pipes leaving Swamp Lake

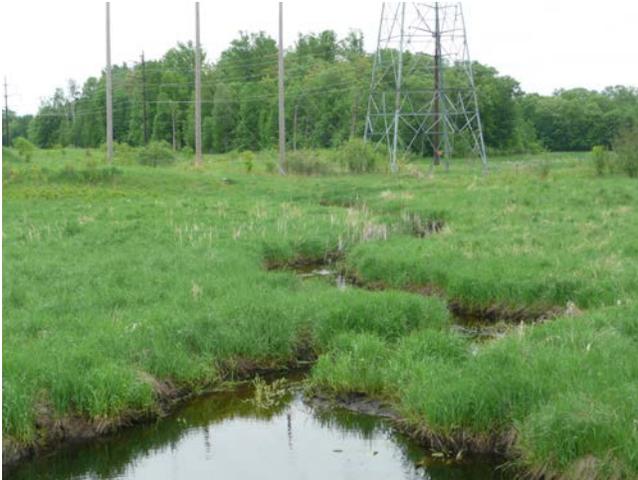
North of the Creek Crossing at County Road 19 there is a pinch point that has been historically used by Beavers. The District has obtained easements over this area and has worked with the landowner to implement some modifications to limit this pinch point to reduce the likelihood of water backups from Beavers. This work was completed in 2013. It is recommended that the site be visited in the next month or so to assess vegetation establishment and whether there is additional beaver activity.

Photos: Bloomquist Creek at north of County Road 19

- Assess the site for any follow up restoration needs.

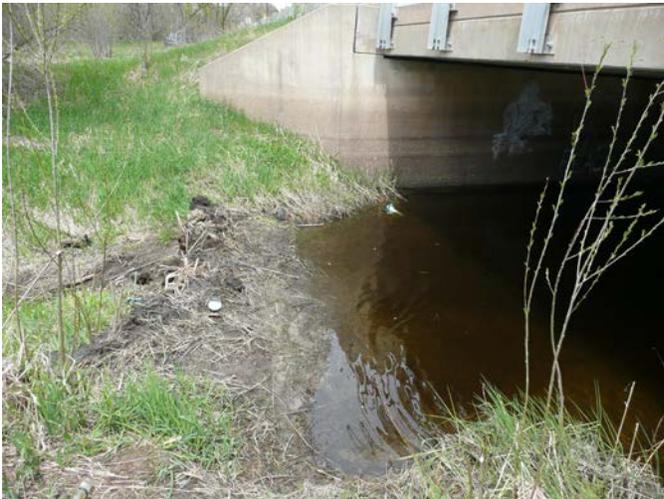
Photo: Beaver Dam near County Road 20

The channel at the outlet of North Center Lake was visited. The channel was partially full of water at the time of the inspection. A beaver dam was obstructing flow at the downstream side of the County Road 20 Bridge. Since the time of this inspection the site has been visited a couple additional times. The water levels have gone up, the dam partially washed out, and water is flowing from North Center to North Lindstrom Lake. Additional beaver activity was not noted. It is recommended that the dam be removed with hand shovels. If the dam is rebuilt, it is recommended that a beaver trapper be brought in to relocate the Beaver

- Remove Beaver Dam
