Date | 8-26-2014

To | Chisago Lakes LID Board of Managers

Regarding | Spring Channel and Outlet Structure Inspection

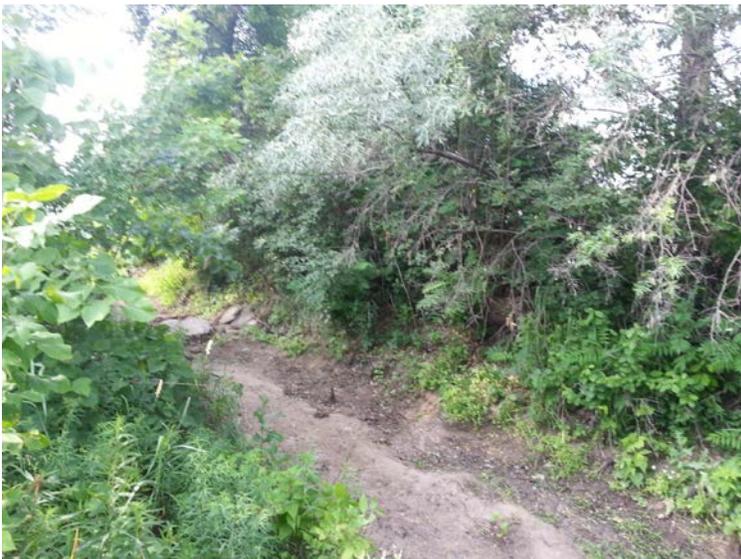
The upstream portion of the channel from Chisago Lake to Wallmark Lake was inspected. The channel area near Stinson Avenue appeared to be stable and the existing rock check dam appears to be eliminating any further head cutting and erosion of the channel. Water levels have risen substantially on Chisago Lake. The downstream section of this ditch was not visited during this inspection.

Photos: channel near Chisago Lake

➤ None

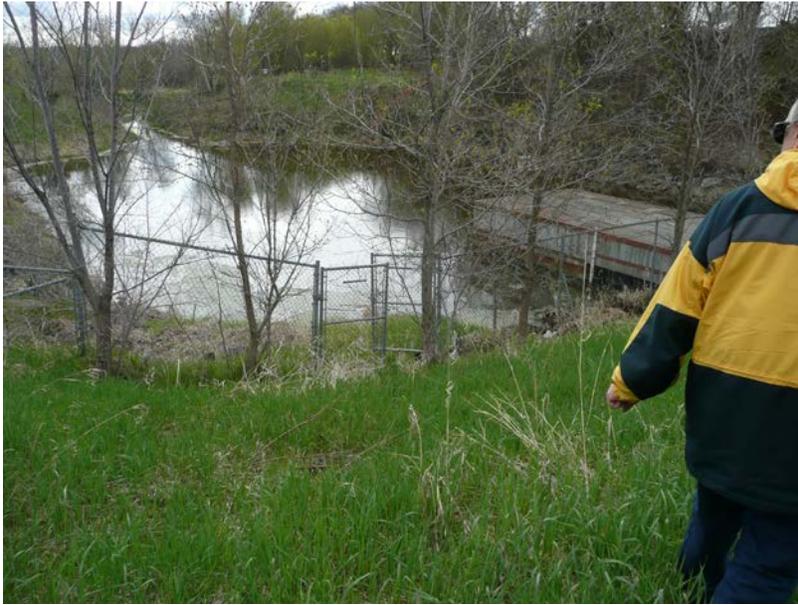
The outlet structure connecting the channel from Chisago Lake to Green Lake was visited. The gates were tested and were working correctly. One of the gates on the fence was open at the time of the inspection last inspect. A new lock was purchased and installed on the gate. A lift handle was also installed on the access hatch to ease opening when the wood is swollen due to moisture.

Photos: Gate with missing lock

- None

- Monitor site for continued beaver activity and need for beaver control.

- Tested Gate Operation
- Installed new lock on fence gate
- Installed lift handle on access hatch

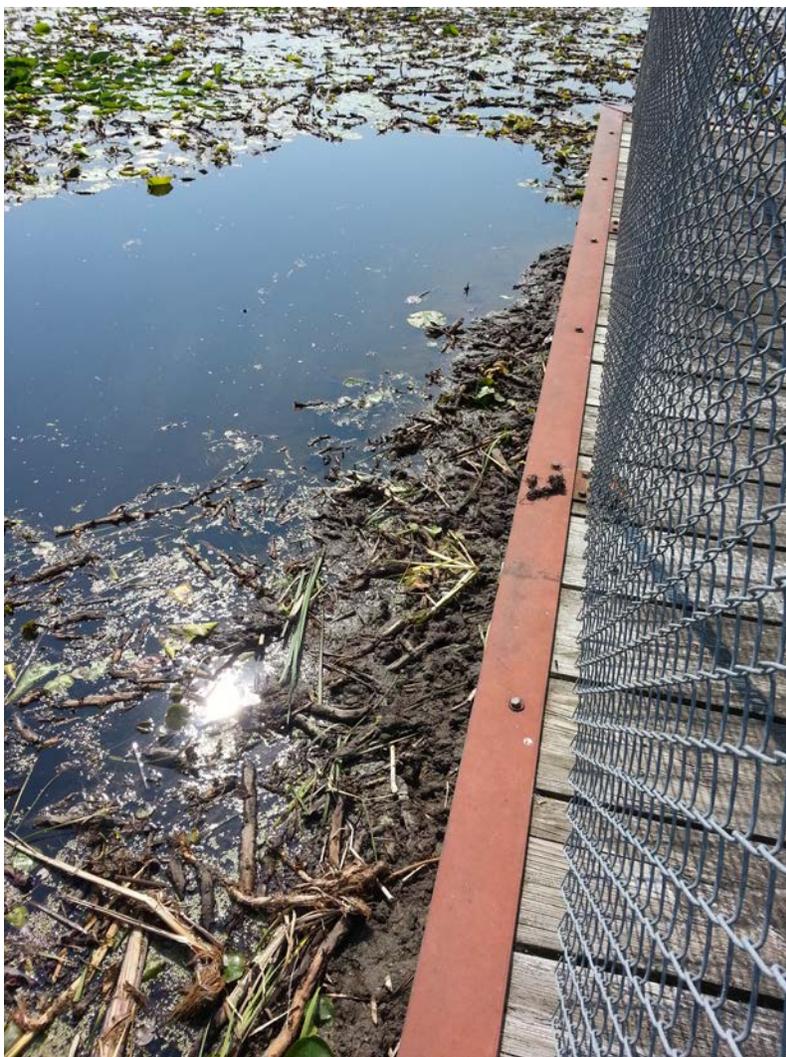
The gate was opened on June 27th due to rising water levels on Green Lake. Significant beaver sediment and debris build up was noted around the entire structure. This was initially thought to be Beaver activity, but upon talking to a trapper he did not find sign of beaver activity in the area. Water was no longer going over the structure at the time of the inspection. The sediment and debris should be removed. If continued maintenance is needed additional measures might be needed to ensure a free flowing structure.

Photo: Lake Ellen Outlet Structure-beaver activity

- Remove mud and debris from around structure

- Monitor Erosion Control Device in farm field for needed maintenance
- Monitor for ongoing mud and debris build up

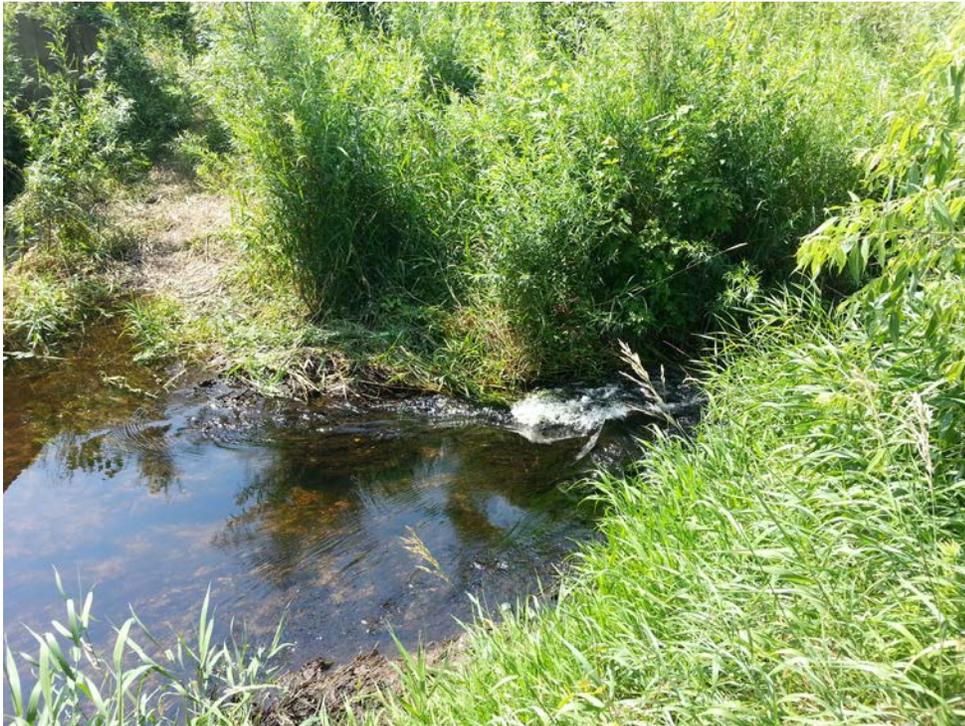
Photo: Beaver Dam location near County Road 20 – after removal

The channel at the outlet of North Center Lake was visited. The channel was flowing at the time of the inspection. A beaver dam was obstructing flow at the downstream side of the County Road 20 Bridge during the previous inspection. The dam has since been removed and no further activity was noted.

- Monitor for continued beaver activity

- Beaver Dam Removed
