Regarding | Spring Channel and Outlet Structure Inspection

On May 5, 2015 an inspection of the Chisago Lakes Outlet Channels and Structures was conducted. Chisago County staff Jerry Spetzman along with EOR engineer Greg Graske performed the field inspection of the channel system. The following summarizes the inspection, actions performed, and any future actions recommend. Actions in red are recommended for follow up in the near future, actions in orange are actions that require future follow up or monitoring but are not urgent, and actions in green are minor maintenance items that were completed in field prior to this report.

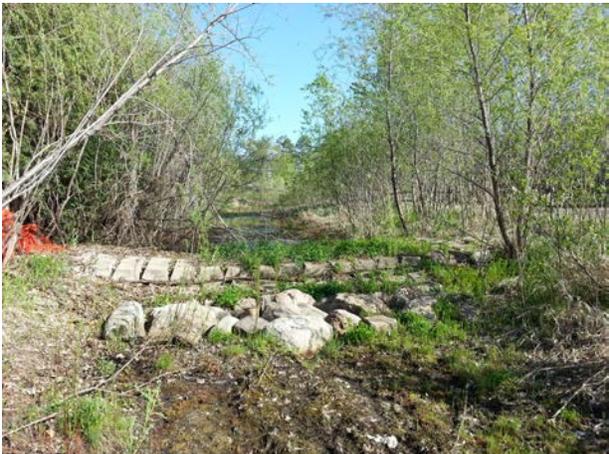
The channel from Chisago Lake to Wallmark Lake was inspected. The channel area near Stinson Avenue appeared to be stable and the existing rock check dam appears to be eliminating any further head cutting and erosion of the channel. The trees along the channel section between Highway 8 and North Avenue were cleared three years ago. The overflow weir just north of Chisago Lake was cleared of vegetation several years ago. Vegetation is starting to regrow on the weir. Currently this is not causing any issues, however it should be monitored during future inspections and scheduled for clean up if small trees start to take hold.

Photos: Left – Over flow Weir, Right - Sportsman Drive culvert

- Monitor vegetation growth on weir and consider future removal

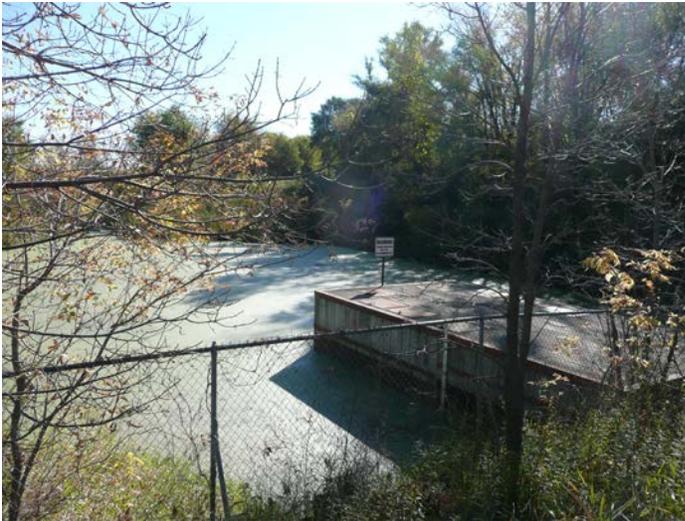
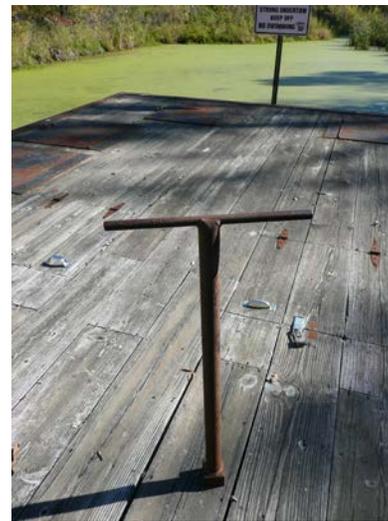
The outlet structure connecting the channel from Chisago Lake to Green Lake was visited. Several repairs were made to the structures in 2012. These repairs included fixing one of the gates, fixing the fence, and repairing a leak. The gates were tested and were working correctly. Water was observed flowing from the wetland area to Green Lake when opened. The gates were returned to the closed position upon completion of the inspection.

Photos: Outlet Structure

- Finish new tool for opening and closing gates

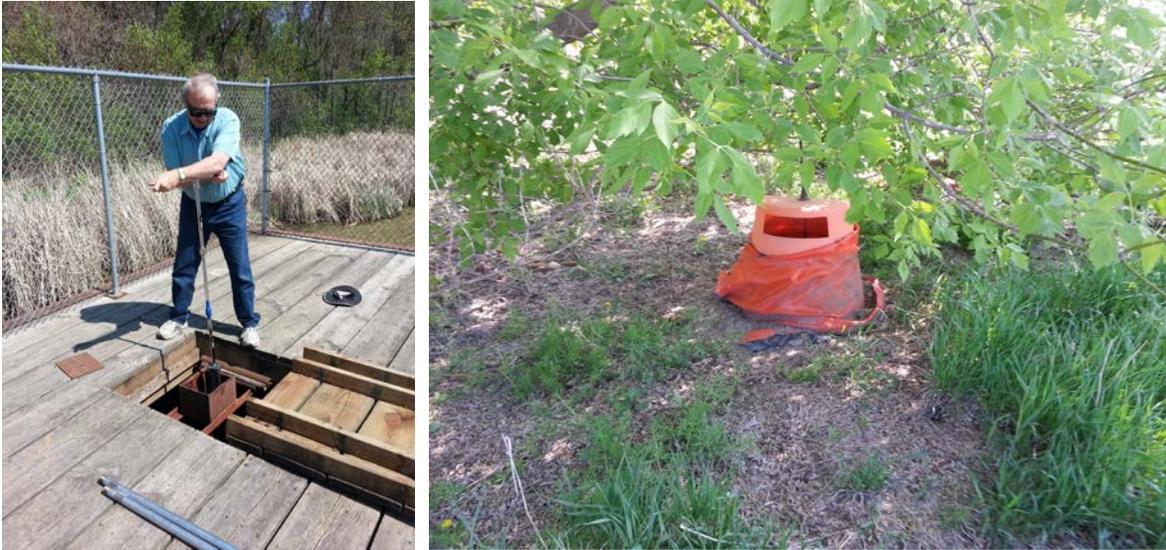
A repair to the gate mechanism, clearing of vegetation and replacement of the missing control box cover was completed in 2012. The gate was exercised and appeared to be operational. The gate was opened on June 27th, 2014 due to rising water levels on Green Lake. The water levels receded and the gate was closed on November 3rd, 2014. During operations debris built up around the outside perimeter of the weir. The debris surrounding the weir was removed this spring by a contractor. Some repairs to the fence on top of the structure were also completed at that time.

Photo: Left - Lake Ellen Outlet Structure. Right – Field Inlet

- Monitor Erosion Control Device in farm field for needed maintenance

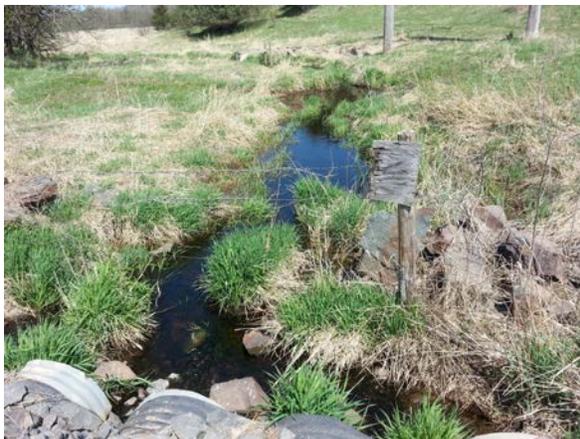
The Swamp Lake outlet pipes under County Road 80 were visited. This location has 7 pipes under the road to convey flow. Obstructions previously noted have been removed. No concerns were noted.

Photos: Pipes leaving Swamp Lake
