Date | 9-9-2015

To | Chisago Lakes LID Board of Managers

Regarding | Summer Channel and Outlet Structure Inspection

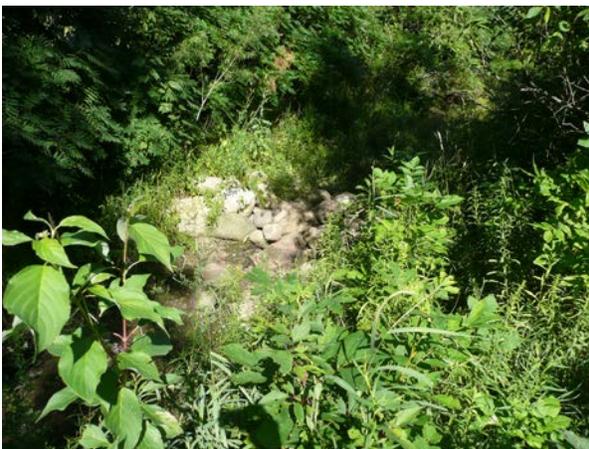
The channel from Chisago Lake to Wallmark Lake was inspected. The channel area near Stinson Avenue appeared to be stable and the existing rock check dam appears to be eliminating any further head cutting and erosion of the channel. The trees along the channel section between Highway 8 and North Avenue were cleared three years ago. The overflow weir just north of Chisago Lake was cleared of vegetation several years ago. Vegetation is starting to regrow on the weir. Currently this is not causing any issues, however it should be monitored during future inspections and scheduled for clean up if small trees start to take hold. The trash rack at the sportsman drive culvert was covered with branches, trash and debris. This was removed at the time of the inspection.

Photos: Left – Rock Check Dam. Right - Sportsman Drive culvert covered with debris

- Monitor vegetation growth on weir and consider future removal

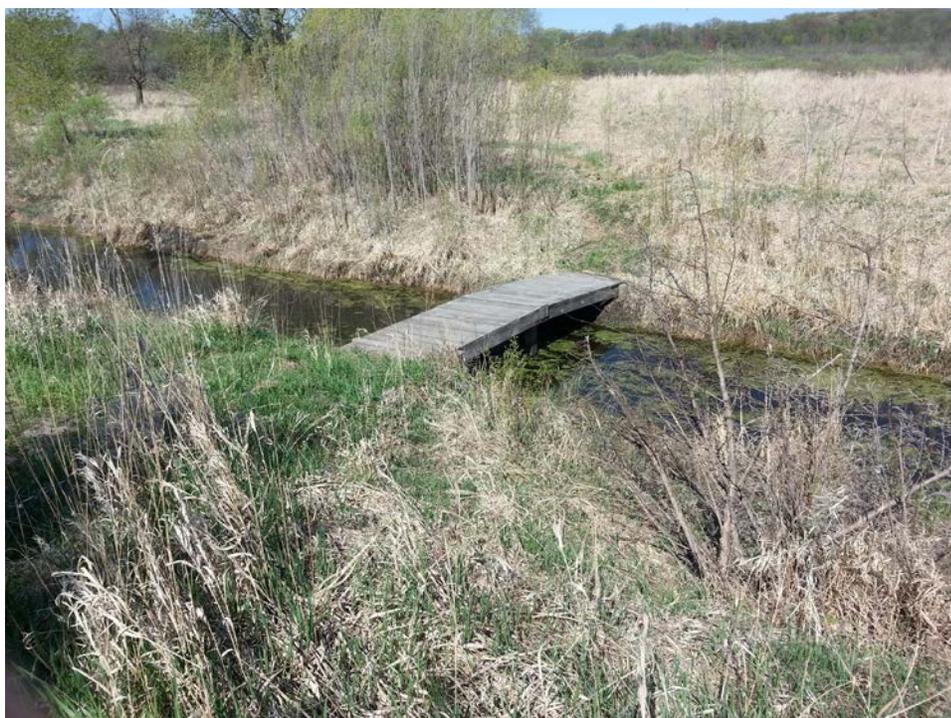
As noted in the spring inspection report, a bridge crossing has been constructed at about the halfway point along the channel. It is unclear who constructed this bridge and for what purpose. In the past there have been planks and ladders seen across the channel and it was assumed that this was being used by hunters to gain access to the other side of the channel. The new bridge is much more substantial and would likely create a measurable obstruction during high water flows through the channel.

Photos: Bridge Crossing during Spring Inspection

- Wait on direction from County

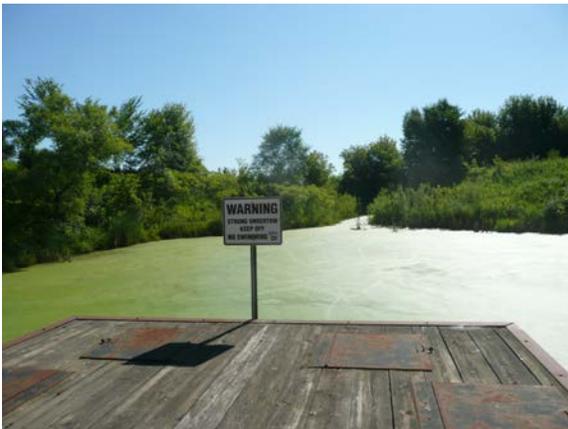
The outlet structure connecting the channel from Chisago Lake to Green Lake was visited. Several repairs were made to the structures in 2012. These repairs included fixing one of the gates, fixing the fence, and repairing a leak. The gates were tested and were working correctly. Water was observed flowing from the wetland area to Green Lake when opened. The gates were returned to the closed position upon completion of the inspection. The fenced entrance to the structure is being overtaken by woody vegetation. It is recommended that this be cleared with hand loppers during the fall channel and weir inspection.

Photos: Left - outlet structure. Right – entrance fence being overtaken by woody vegetation.

- Finish new tool for opening and closing gates

- Tested gate operation

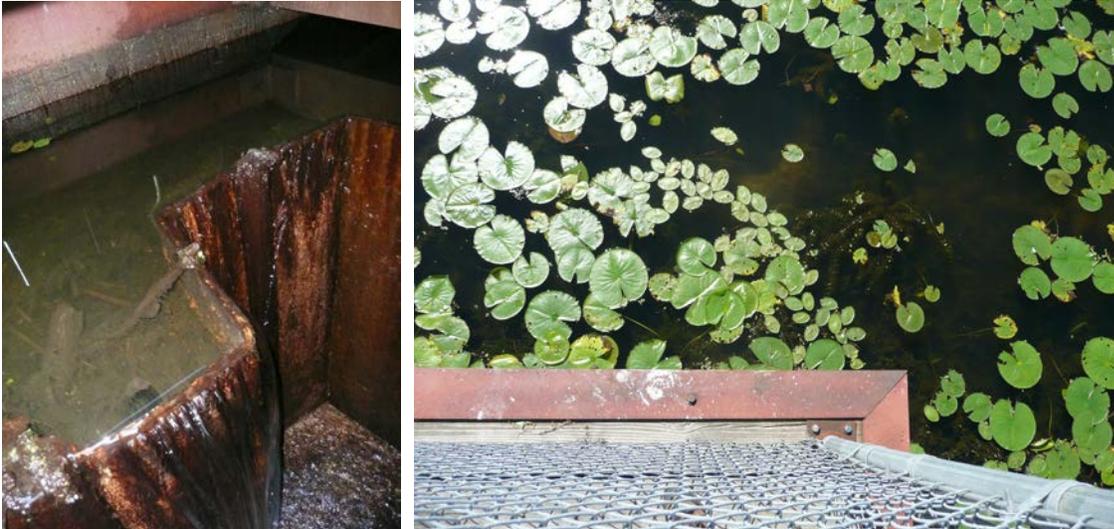
A repair to the gate mechanism, clearing of vegetation and replacement of the missing control box cover was completed in 2012. The gate was opened on June 27th, 2014 due to rising water levels on Green Lake. The water levels receded and the gate was closed on November 3rd, 2014. During operations debris built up around the outside perimeter of the weir. The debris surrounding the weir was removed this spring by a contractor. Some repairs to the fence on top of the structure were also completed at that time. Due to high water levels the gate was again opened on July 23rd, 2015 with a few inches of water flowing over the weir. By the time of this inspection on July 30th, the water level has receded such that the water was just barely overtopping the weir. The gates should be closed at the time of the fall inspection (if they have not been already) and the structure inspected for debris build up around the perimeter.

Photo: Left – Sheet Pile Weir inside of structure. Right – Outside edge of structure

- Close gates at next inspection (dependent on water levels)

- Monitor erosion control device in farm field for needed maintenance
- Inspect perimeter of structure for sediment and debris build up

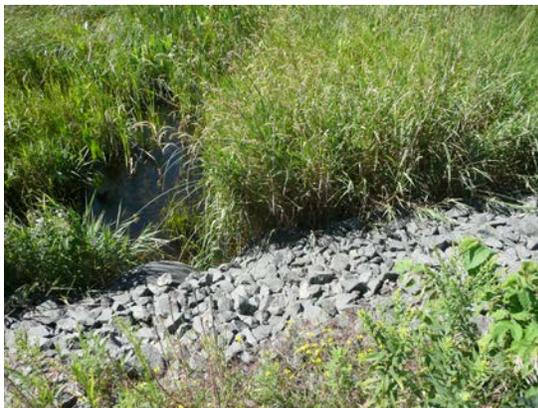
The Swamp Lake outlet pipes under County Road 80 were visited. This location has 7 pipes under the road to convey flow. Vegetation is starting to get thick near several of the culverts. This should be monitored and scheduled for cleanout if needed.

Photos: Pipes leaving Swamp Lake

- Monitor vegetation build up, reassess for possible removal next year
