**Date** | 2-24-2016  
**To** | Chisago Lakes LID Board of Managers  
**cc** | Jerry Spetzman  
**From** | Greg Graske  
**Regarding** | Winter Channel and Outlet Structure Inspection

### **Outlet Structure and Pipe between Lake Ellen and Swamp Lake**

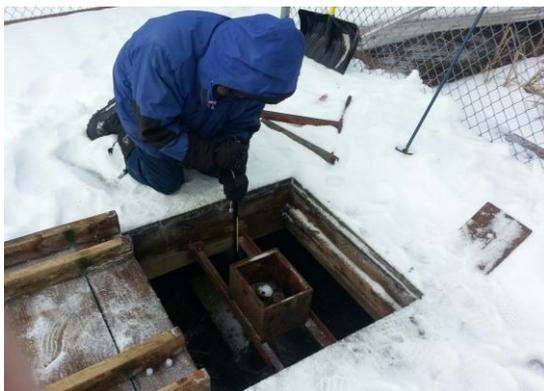
Due to high water levels the gate was opened on July 23rd, 2015 with a few inches of water flowing over the weir. By the time of the inspection on July 30th, the water level has receded such that the water was just barely overtopping the weir. The gates were closed during the fall inspection and the structure inspected for debris build up around the perimeter. Significant debris build up was not observed. Due to high precipitation in November, water levels rose slightly above the weir just prior to freeze up. Due to ice safety concerns and following the Emergency Management Plan the gates were left closed. A winter inspection was performed to determine the need to open the gates and to assess the ability to operate the gates in the winter. Water levels had not significantly increased, therefore the management plan called for the gates to remain closed. The door had to be broken loose due to ice and snow build up. After chiseling around the shaft we were able to slightly open the gate, but it was very stiff due to the ice and cold. The gate was returned to the shut position. Once spring melt occurs the gates will be opened to allow for spring flows. An inspection is scheduled for March 10th to determine if the gates should be opened.

Photo: outlet structure access door

- Open gates once spring melt allows

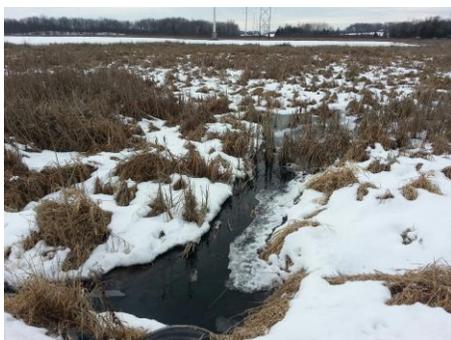
The Swamp Lake outlet pipes under County Road 80 were visited. This location has 7 pipes under the road to convey flow. Water was flowing at the time of the inspection. Vegetation is starting to get thick near several of the culverts. It is recommended that this vegetation be removed by a contractor in 2016.

Photo: Pipes leaving Swamp Lake

- Have contractor remove vegetation build up in 2016

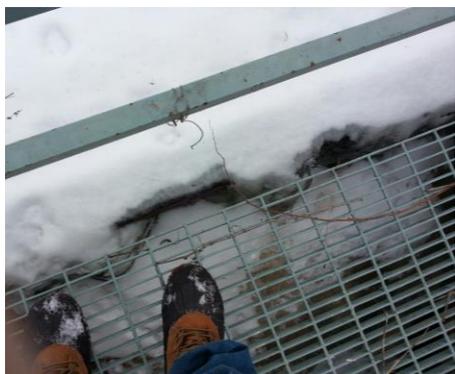
The culvert crossing under Ivywood Trail was visited. This site is not generally part of the outlet conveyance due to the outlet channel to Carlos Avery WMA never being fully completed. No issues noted.

Photo: Top view of outlet structure

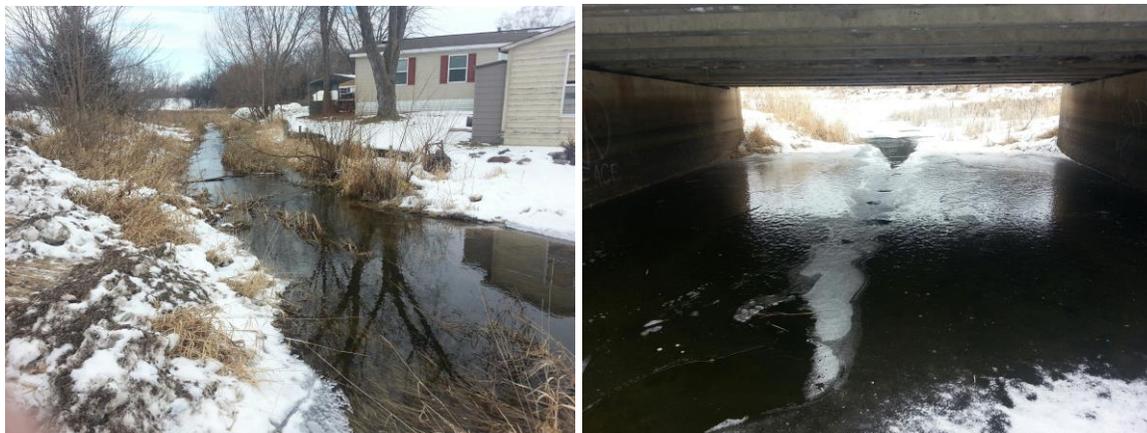
The channel between North Center Lake and North Lindstrom Lake was visited. Significant flow between the lakes was observed. No issues were noted.

Photo: Left: channel leaving North Center Lake, Right: flow under County Road 20 Bridge
