Date | 11-25-2015

To | Chisago Lakes LID Board of Managers

From | Greg Graske

Regarding | Summer Channel and Outlet Structure Inspection

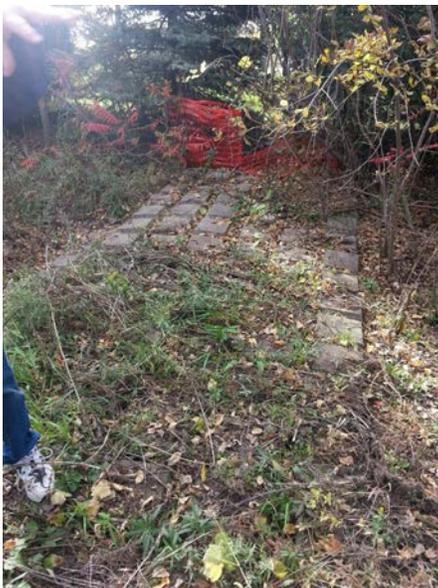
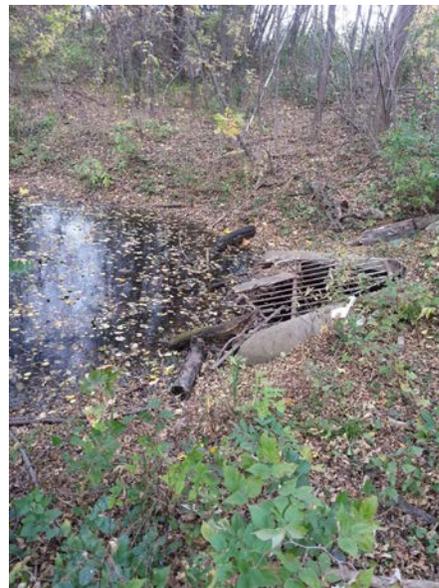
The channel from Chisago Lake to Wallmark Lake was inspected. The channel area near Stinson Avenue appeared to be stable and the existing rock check dam appears to be eliminating any further head cutting and erosion of the channel. The trees along the channel section between Highway 8 and North Avenue were cleared three years ago. Small trees and brush were starting to grow on the overflow weir north of Chisago Lake. This vegetation was cleared during this inspection. The trash rack at the sportsman drive culvert was covered with branches, trash and debris. This was removed at the time of the inspection.

Photos: Left – Overflow weir after removal of trees and brush. Right - Sportsman Drive culvert covered with debris

- Monitor tree growth between Highway 8 and North Avenue

- Debris Cleared from Sportsman Drive culvert trash rack
- Small trees and brush removed from Chisago overflow weir

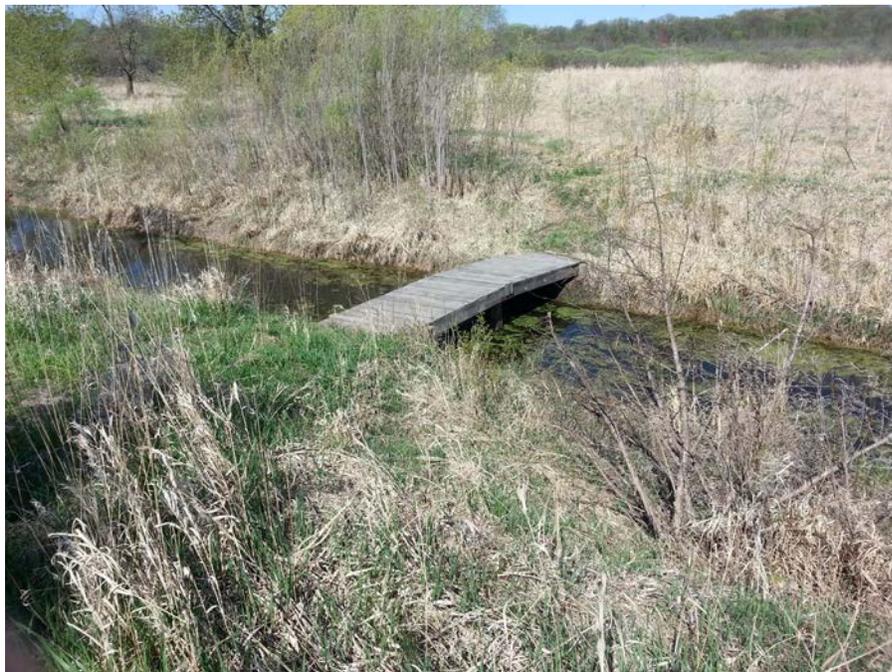
As noted in the spring inspection report, a bridge crossing has been constructed at about the halfway point along the channel. It is unclear who constructed this bridge and for what purpose. In the past there have been planks and ladders seen across the channel and it was assumed that this was being used by hunters to gain access to the other side of the channel. The new bridge is much more substantial and would likely create a measurable obstruction during high water flows through the channel.

Photos: Bridge Crossing during Spring Inspection

- Wait on direction from County

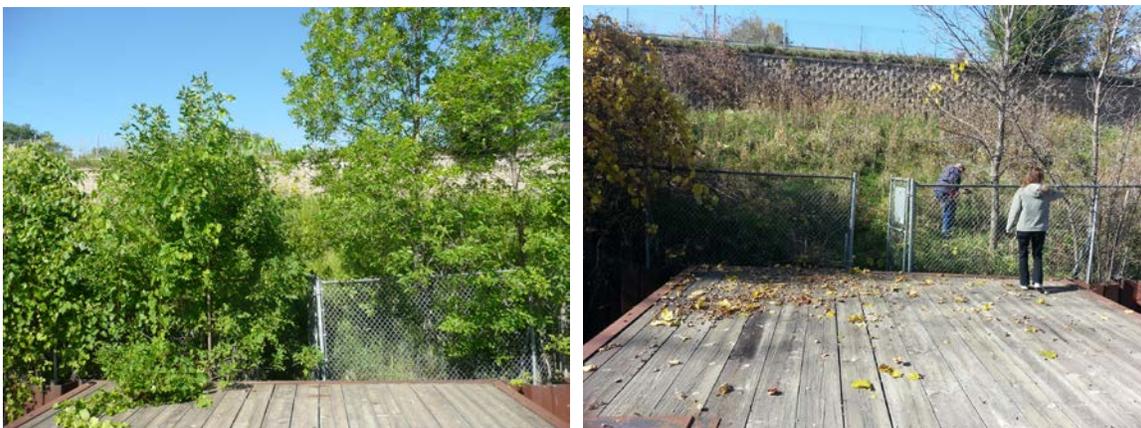
The outlet structure connecting the channel from Chisago Lake to Green Lake was visited. Several repairs were made to the structures in 2012. These repairs included fixing one of the gates, fixing the fence, and repairing a leak. During the last inspection it was noted that the fenced entrance to the structure is being overtaken by woody vegetation. This vegetation was cleared with hand loppers during this inspection.

Photos: Left– entrance fence being overtaken by woody vegetation (summer). Right – entrance fence after clearing of woody vegetation.

- Clear woody vegetation near entrance to outlet structure

- Cleared woody vegetation near entrance to outlet structure

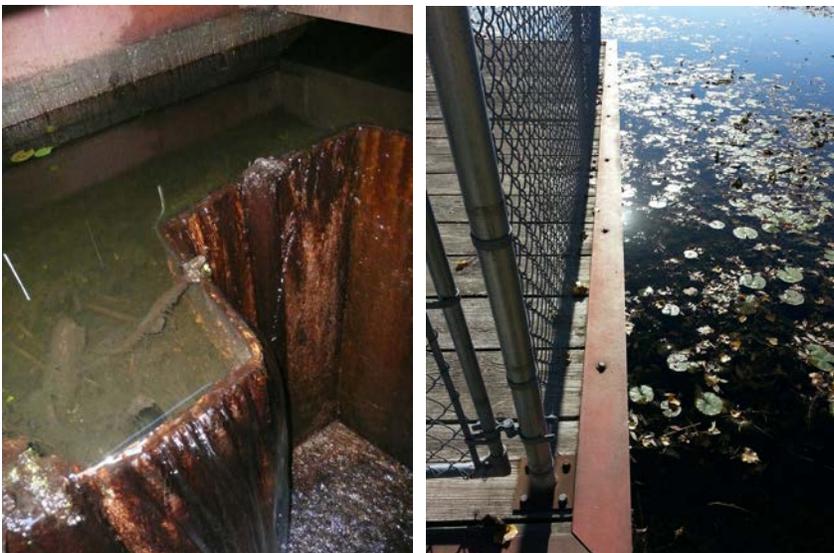
A repair to the gate mechanism, clearing of vegetation and replacement of the missing control box cover was completed in 2012. The gate was opened on June 27th, 2014 due to rising water levels on Green Lake. The water levels receded and the gate was closed on November 3rd, 2014. During operations debris built up around the outside perimeter of the weir. The debris surrounding the weir was removed this spring by a contractor. Some repairs to the fence on top of the structure were also completed at that time. Due to high water levels the gate was again opened on July 23rd, 2015 with a few inches of water flowing over the weir. By the time of the inspection on July 30th, the water level has receded such that the water was just barely overtopping the weir. The gates were closed during the fall inspection and the structure inspected for debris build up around the perimeter. Significant debris build up was not observed.

Photo: Left – Sheet Pile Weir inside of structure (summer). Right – Outside edge of structure (fall)

- Monitor erosion control device in farm field for needed maintenance

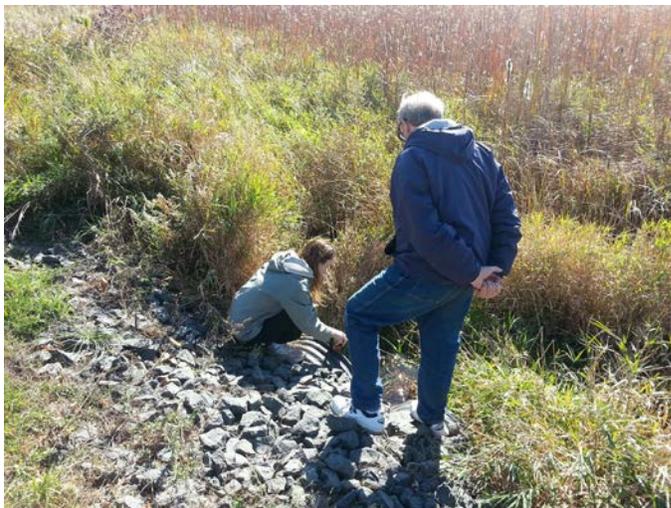
The Swamp Lake outlet pipes under County Road 80 were visited. This location has 7 pipes under the road to convey flow. Vegetation is starting to get thick near several of the culverts. It is recommended that this vegetation be removed by a contractor in 2016.

Photo: Pipes leaving Swamp Lake

- Have contractor remove vegetation build up in 2016

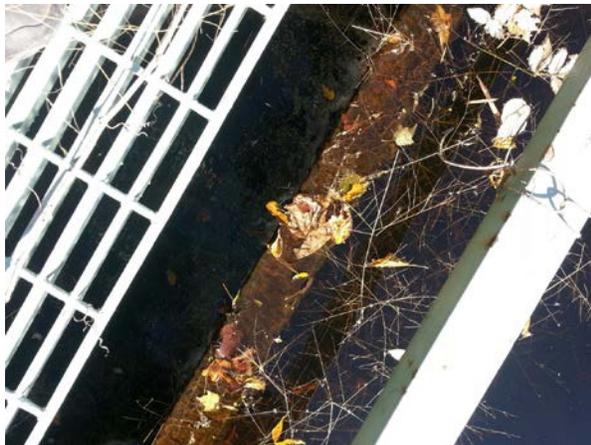
The culvert crossing under Ivywood Trail was visited. This site is not generally part of the outlet conveyance due to the outlet channel to Carlos Avery WMA never being fully completed. No issues noted.

Photo: Top view of outlet structure
