**Regarding** | Spring Channel and Outlet Structure Inspection

On May 18, 2016 an inspection of the Chisago Lakes Outlet Channels and Structures was conducted. EOR engineer Greg Graske and District administrator Jerry Spetzman performed the field inspection of the channel system. The following summarizes the inspection, actions performed, and any future actions recommend. Actions in red are recommended for follow up in the near future, actions in orange are actions that require future follow up or monitoring but are not urgent, and actions in green are minor maintenance items that were completed in field prior to this report.

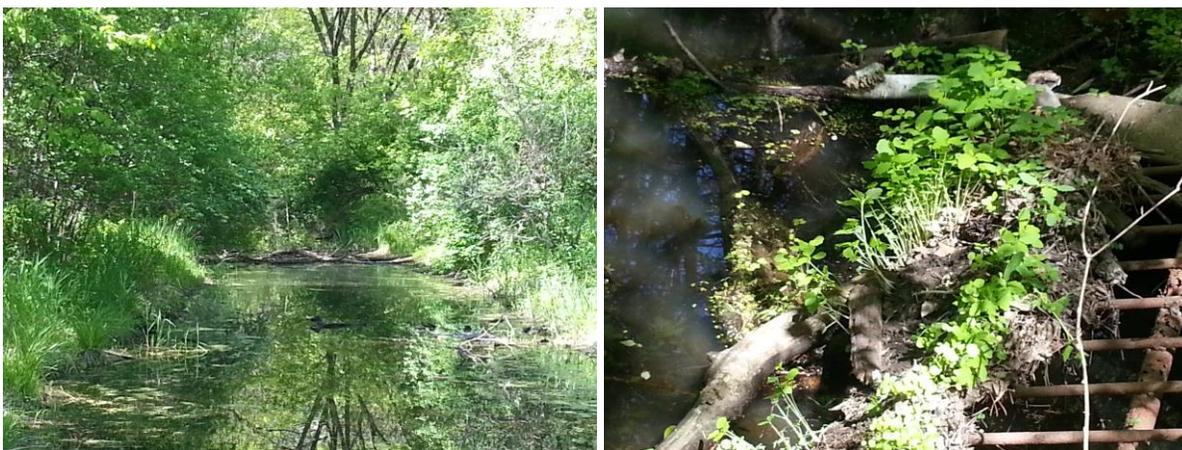
The channel from Chisago Lake to Wallmark Lake was inspected. The channel area near Stinson Avenue appeared to be stable and the existing rock check dam appears to be eliminating any further head cutting and erosion of the channel. Water is now starting to fill the portion of the channel closest to Chisago Lake as water levels rise. The trees along the channel section between Highway 8 and North Avenue were cleared three years ago, this are starting to grow back and additional maintenance may be needed in the near future. In addition, sediment build up was noted in the culverts. The trash rack at the sportsman drive culvert was covered with branches, trash and debris. This was removed at the time of the inspection. West of Lake Pointe Drive there was a build of woody debris which should be removed.

Photos: Left – Woody debris in channel west of Lake Pointe Drive. Right - Sportsman Drive culvert covered with debris

- Remove woody debris in channel west of Lake Pointe Drive

- Debris Cleared from Sportsman Drive culvert trash rack

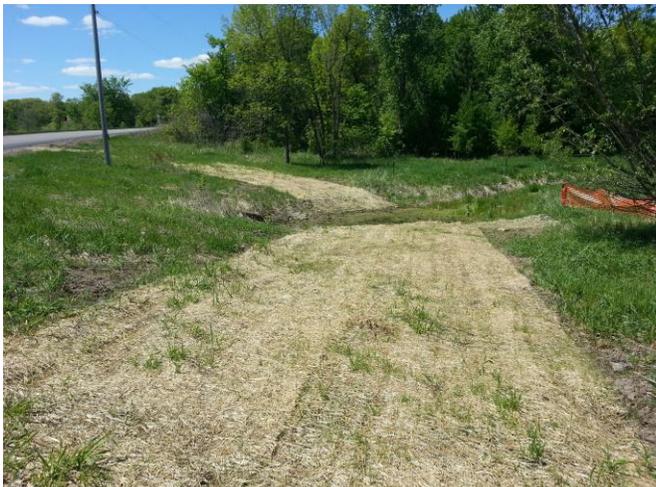
Sediment build up at the County Road 23 culvert was removed by the County and erosion control blankets were placed over the disturbed areas adjacent to the channel.

Photos: Culverts under County Road 23

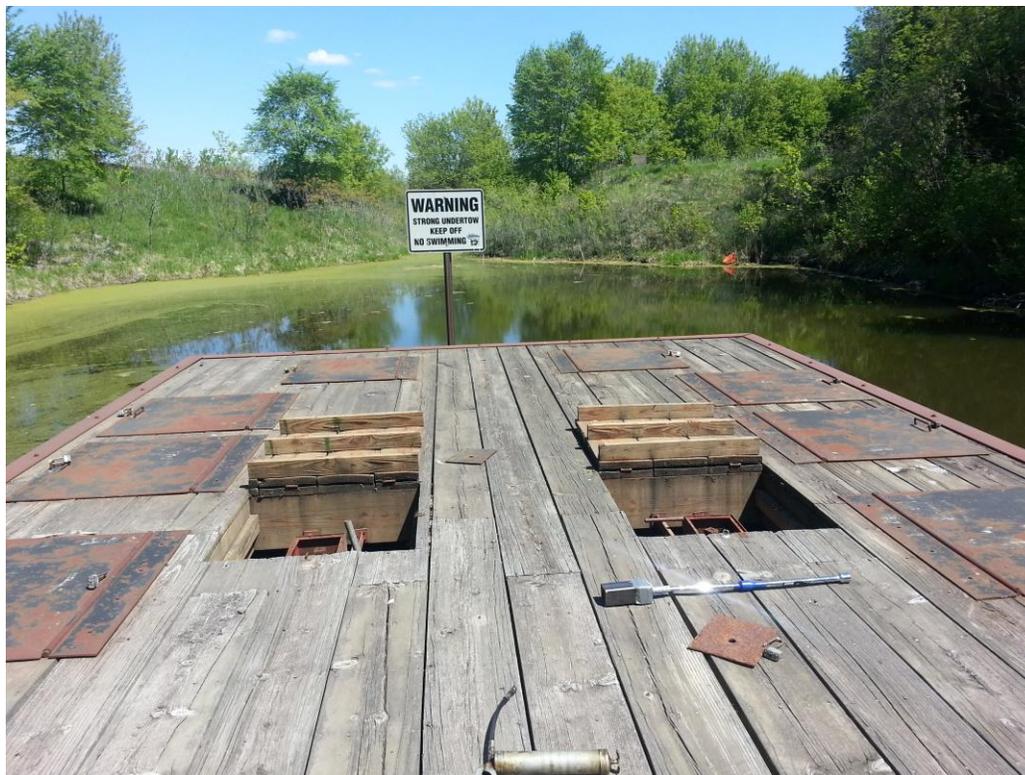
The outlet structure connecting the channel from Chisago Lake to Green Lake was visited. No issues were noted. The gates were tested and the greased.

Photos: Outlet Control Structure

- Gates tested and greased control gate mechanism

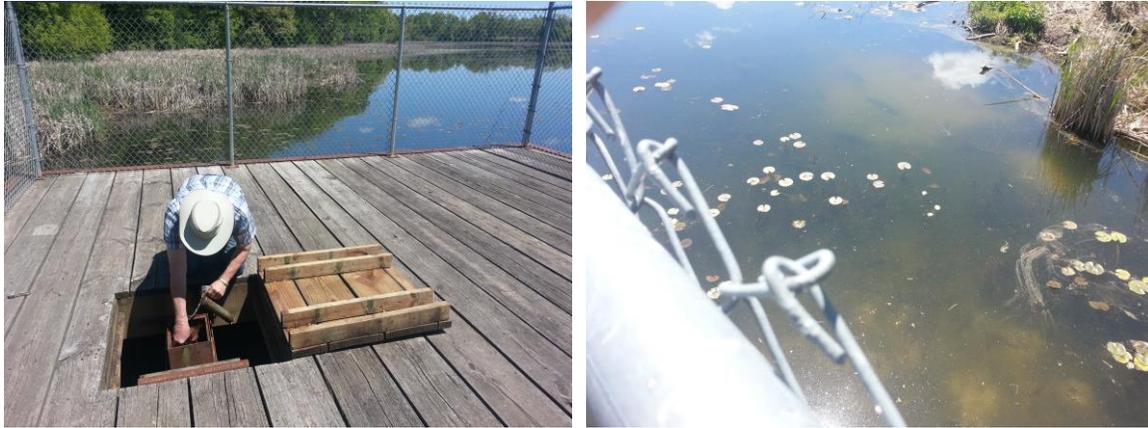
No issues were noted at the time of the inspection. The gates were opened in the spring and will remain open until fall. A large number of carp were noted in Lake Ellen at the time of the inspection.

Photo: Left – Greasing Control Box fittings. Right – Carp near structure

- Greased control gate mechanism

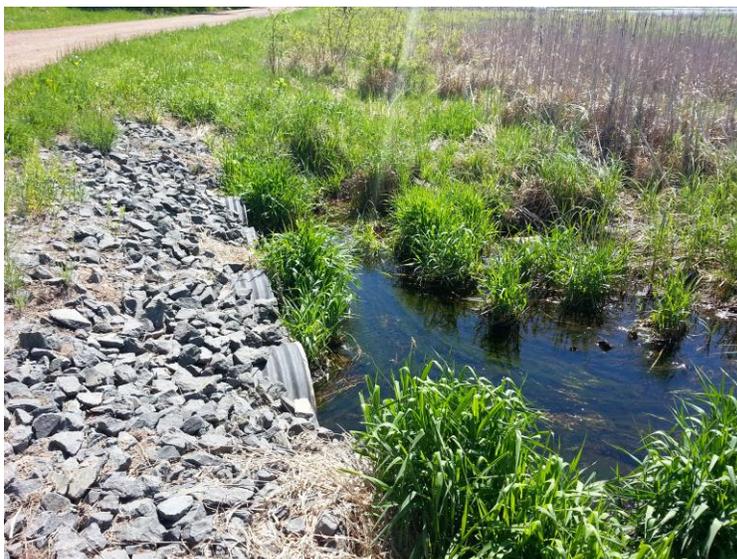
The Swamp Lake outlet pipes under County Road 80 were visited. This location has 7 pipes under the road to convey flow. Vegetation is starting to get thick near several of the culverts. It is recommended that this vegetation be removed by a contractor in 2016.

Photo: Pipes leaving Swamp Lake

- Have contractor remove vegetation build up in 2016

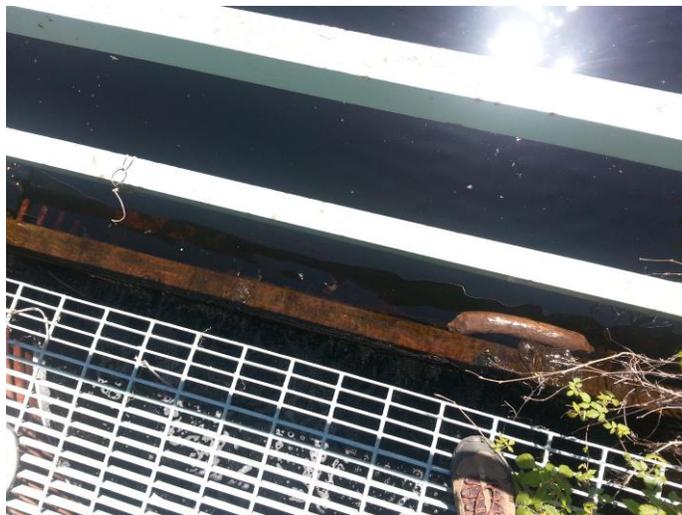
The culvert crossing under Ivywood Trail was visited. This site is not generally part of the outlet conveyance due to the outlet channel to Carlos Avery WMA never being fully completed. No issues noted.

Photo: Top view of outlet structure
