**Date** | 9-6-2016  
**To** | Chisago Lakes LID Board of Managers  
**cc** | Jerry Spetzman  
**From** | Greg Graske  
**Regarding** | Summer Channel and Outlet Structure Inspection

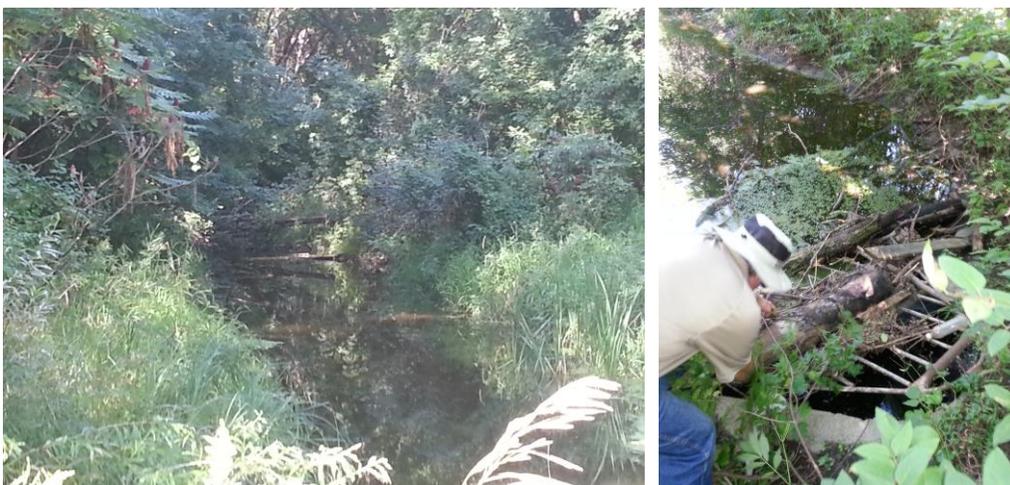
The channel from Chisago Lake to Wallmark Lake was inspected. The channel area near Stinson Avenue appeared to be stable and the existing rock check dam appears to be eliminating any further head cutting and erosion of the channel. Water is now starting to fill the portion of the channel closest to Chisago Lake as water levels rise. The trees along the channel section between Highway 8 and North Avenue were cleared three years ago, this are starting to grow back and additional maintenance may be needed in the near future. The trash rack at the sportsman drive culvert was covered with branches, trash and debris. This was removed at the time of the inspection. West of Lake Pointe Drive there was a build of woody debris which should be removed.

Photos: Left – Woody debris in channel west of Lake Pointe Drive. Right - Sportsman Drive culvert covered with debris

- Remove woody debris in channel west of Lake Pointe Drive

- Debris Cleared from Sportsman Drive culvert trash rack

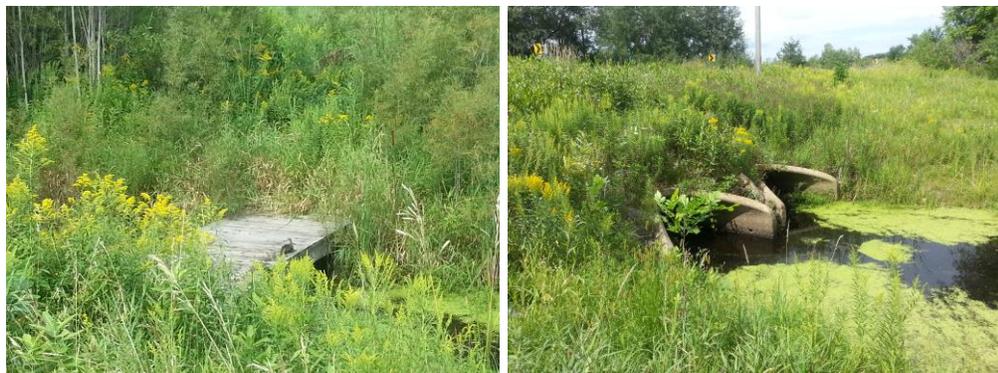
As noted in the 2015 spring inspection report, a bridge crossing has been constructed at about the halfway point along the channel. It is unclear who constructed this bridge and for what purpose. In the past there have been planks and ladders seen across the channel and it was assumed that this was being used by hunters to gain access to the other side of the channel. The new bridge is much more substantial and would likely create a measurable obstruction during high water flows through the channel. Chisago County parks has agreed to remove the bridge and repurpose it elsewhere.

Sediment build up at the County Road 23 culvert was removed by the County and erosion control blankets were placed over the disturbed areas adjacent to the channel. Vegetation is coming in well in the areas of the banks that were disturbed.

Photos: Left – Bridge over channel. Right - Culverts under County Road 23

- County Parks to remove the bridge

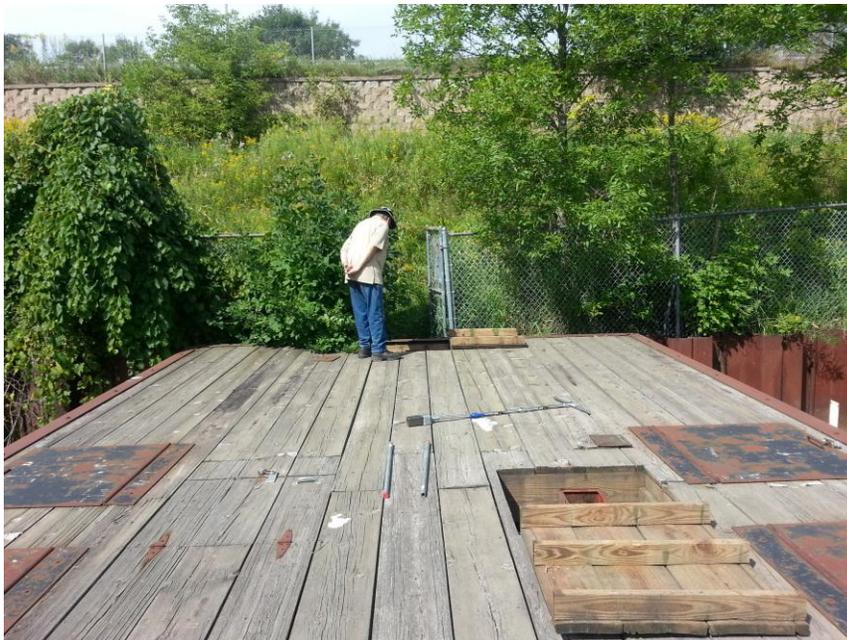
The outlet structure connecting the channel from Chisago Lake to Green Lake was visited. The nut that operates the gates is loose and should be tightened, if possible, with an Allen wrench.

The vegetation along the fence is starting to fill in and could use some trimming. Mice have been using the gate control boxes as nests, a deterrent such as dryer sheets or covers without holes is recommended. The gates were tested and operational.

Photos: Outlet Control Structure

- Minor vegetation maintenance along fence
- Test out mouse deterrent options
- Tighten loose nut with Allen wrench

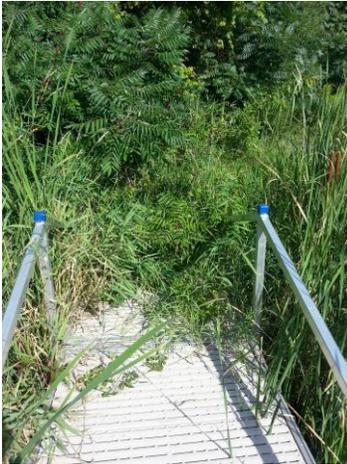
No issues were noted at the time of the inspection. The gates were opened in the spring and will remain open until fall. Vegetation is starting to overtake the ramp and should be cleared during the next inspection

Photo: Left – Ramp leading to weir structure. Right – Water flowing into weir structure

- Monitor erosion control device in farm field for needed maintenance
- Clear vegetation from ramp

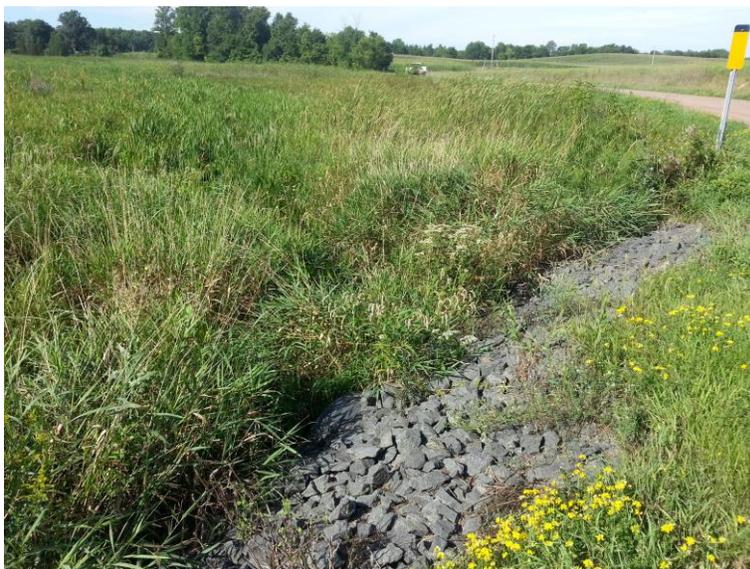
The Swamp Lake outlet pipes under County Road 80 were visited. This location has 7 pipes under the road to convey flow. Vegetation is starting to get thick near several of the culverts. It is recommended that this vegetation be removed by a contractor in 2016.

Photo: Pipes leaving Swamp Lake

- Have contractor remove vegetation build up in 2016

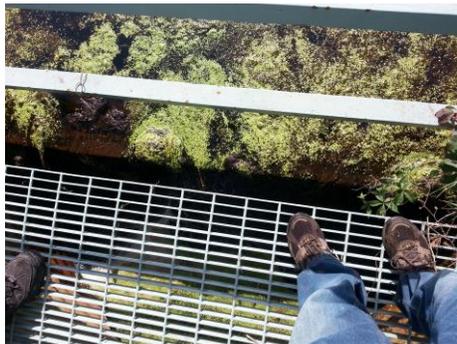
The culvert crossing under Ivywood Trail was visited. This site is not generally part of the outlet conveyance due to the outlet channel to Carlos Avery WMA never being fully completed. No issues noted.

Photo: Top view of outlet structure
