Date | 11-25-2014
To | Chisago Lakes LID Board of Managers
cc | Jerry Spetzman
From | Greg Graske
Regarding | Fall Channel and Outlet Structure Inspection

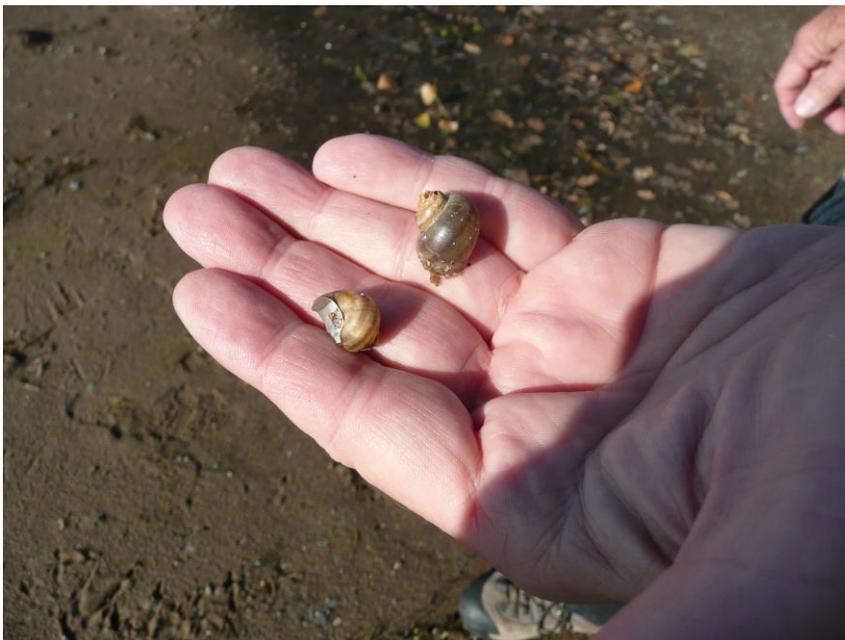
Photos: Banded Mystery Snail at Chisago Lake Beach

The channel from Chisago Lake to Wallmark Lake was inspected. The channel area near Stinson Avenue appeared to be stable and the existing rock check dam appears to be eliminating any further head cutting and erosion of the channel. The trees along the channel section between Highway 8 and North Avenue were cleared two years ago. Banded Mystery Snails were noted at the beach area of Chisago Lake. Included below is a summary that discusses the Banded Mystery Snail taken from the Minnesota DNR website.

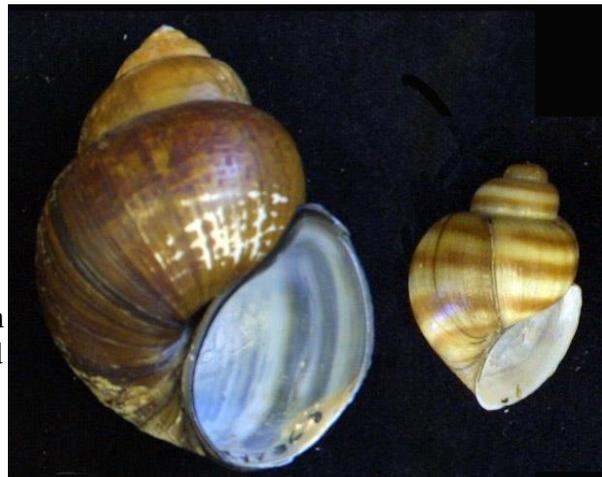
Chinese mystery snail (left) and Banded mystery snail (right)

Keys to identification: Chinese mystery snail has small shallow depressions above the shell opening and rows of fine, short stiff hairs parallel to the whorl of the shell (may wear off with age and abrasion).

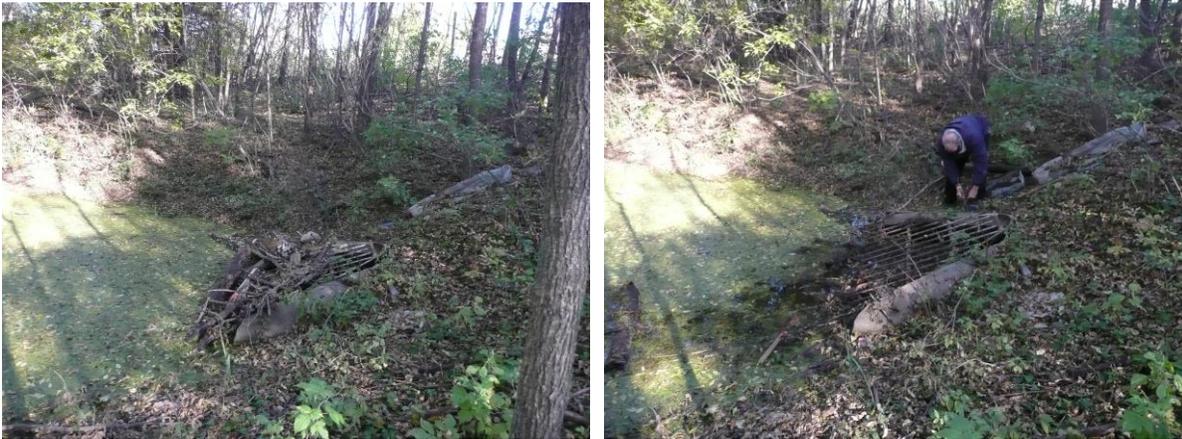
Debris including branches, logs, and trash were noted at the upstream end of the Sportsman Drive Culvert. This debris was removed during the inspection.

Photos: Sportsman Drive culvert before and after debris removal

- Debris Cleared from Sportsman Drive culvert trash rack

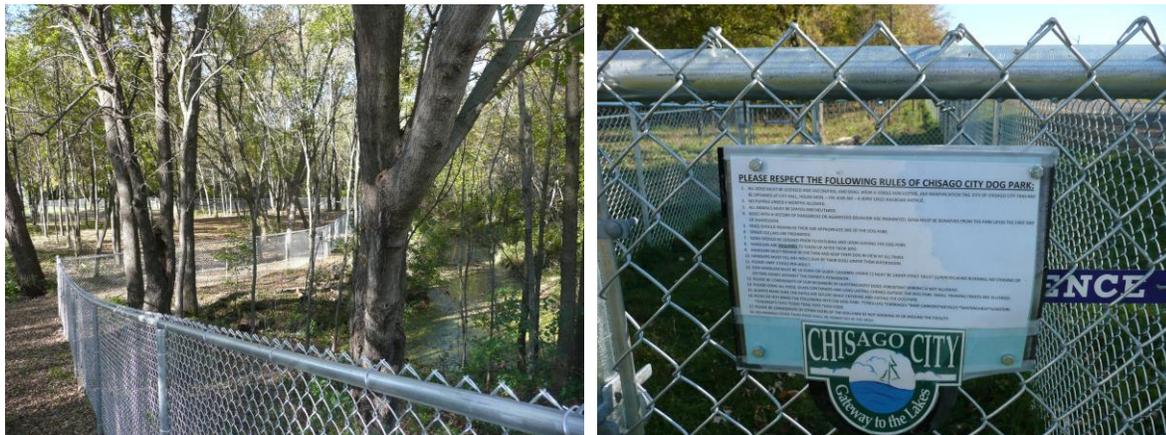
A new dog park was installed adjacent to the channel just upstream of Sportman Drive. The park comes quite close to the channel and could represent a source of nutrient loading to the ditch. It is recommended that coordination with Chisago City occur to discuss Best Management Practices for the park and suggest leaving the edge nearest the channel natural to provide for a natural buffer between the park and the channel.

Photos: New Dog Park

- Have CLLID Administrator contact Chisago City regarding dog park and discuss options for maintaining a buffer area

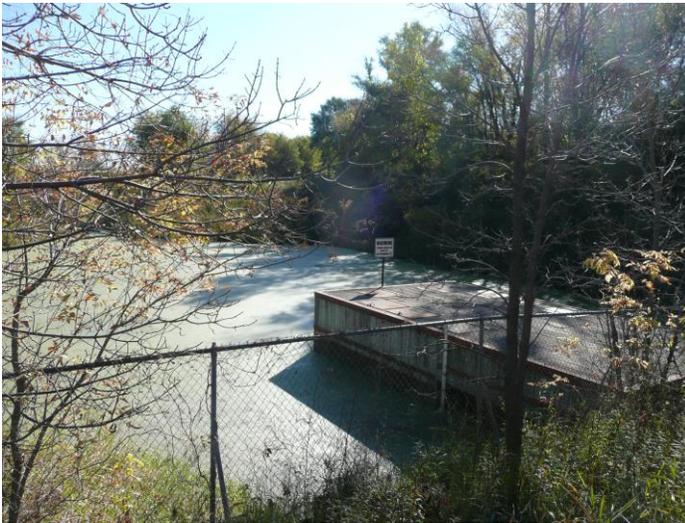
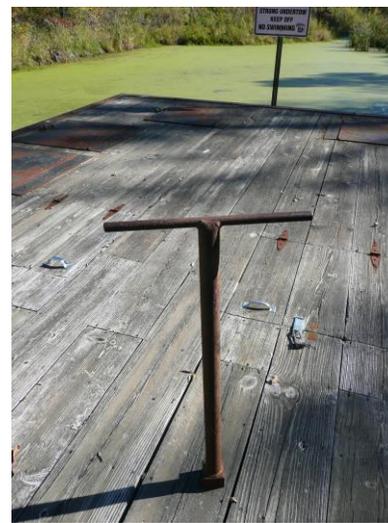
The outlet structure connecting the channel from Chisago Lake to Green Lake was visited. Several repairs were made to the structures in 2012. These repairs included fixing one of the gates, fixing the fence, and repairing a leak. The gates were tested and were working correctly. Water was observed flowing from the wetland area to Green Lake when opened. The gates were returned to the closed position upon completion of the inspection.

Photos: Outlet Structure

- Investigate options for a better tool for opening and closing gates

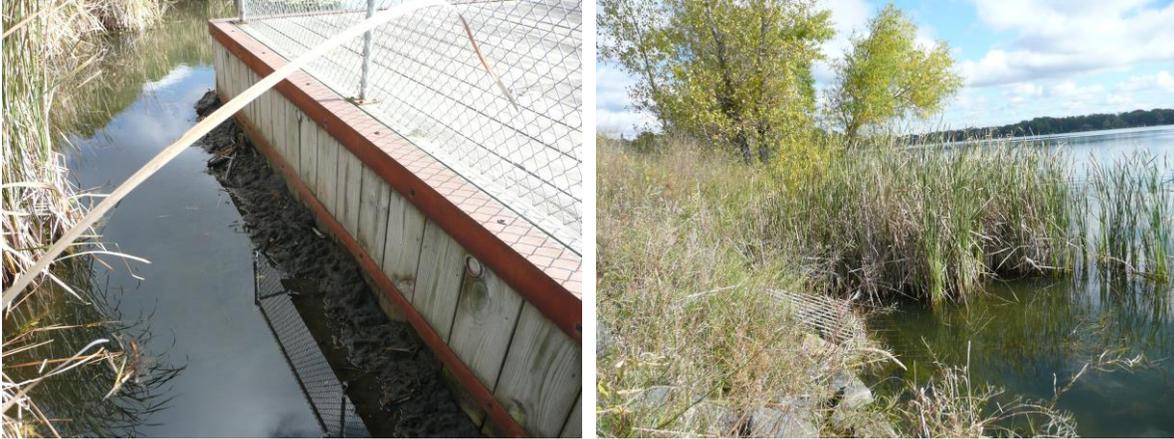
A repair to the gate mechanism, clearing of vegetation and replacement of the missing control box cover was completed in 2012. The gate was exercised and appeared to be operational. The gate was opened on June 27th due to rising water levels on Green Lake. The water levels receded and the gate was closed on November 3rd. The pipes between Little Green Lake and Lake Ellen were also visited. A minor amount of debris was removed from the trash racks. The debris surrounding the weir was scheduled for removal on November 12th. Unfortunately, due to a winter storm on November 10th debris cleanup will be postponed until spring.

Photo: Left - Lake Ellen Outlet Structure. Right – Little Green Lake Outlet

- Removal of debris build up around structure

- Monitor Erosion Control Device in farm field for needed maintenance

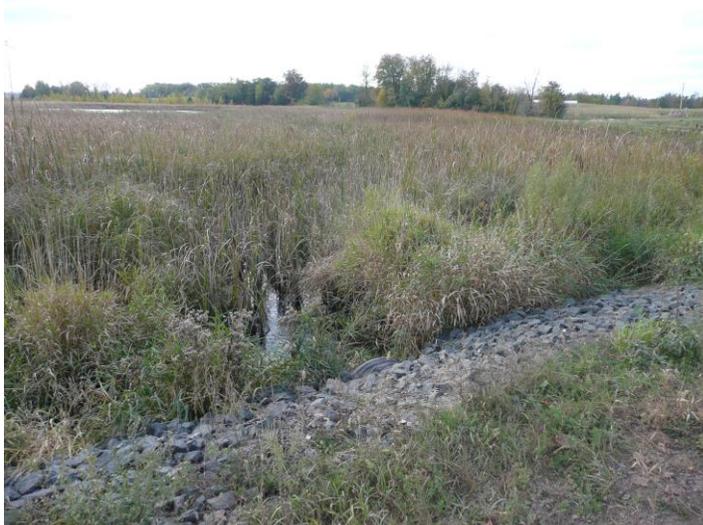
The Swamp Lake outlet pipes under County Road 80 were visited. This location has 7 pipes under the road to convey flow. Obstructions previously noted have been removed. No concerns were noted.

Photos: Pipes leaving Swamp Lake

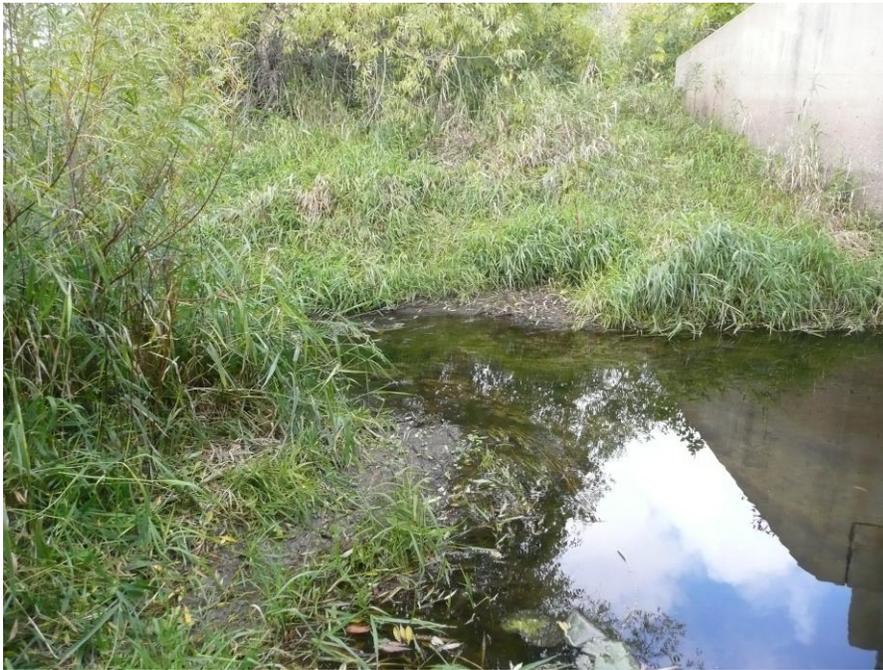
Photo: Removed Beaver Dam near County Road 20

The channel between North Center Lake and North Lindstrom was visited. The channel was partially full of water at the time of the inspection. A beaver dam was obstructing flow at the downstream side of the County Road 20 Bridge during the previous channel inspection. The beaver dam was removed previously and further clean out of debris was performed during this inspection. Additional beaver activity was not noted. It is recommended that the dam area be monitored, and if the dam is rebuilt, it is recommended that a beaver trapper be brought in to relocate the Beaver

- Monitor for ongoing beaver activity

- Removed additional debris from old beaver dam
