EICHTEN PROJECTS

GRASS WATERWAY AND WATER & SEDIMENT CONTROL BASINS

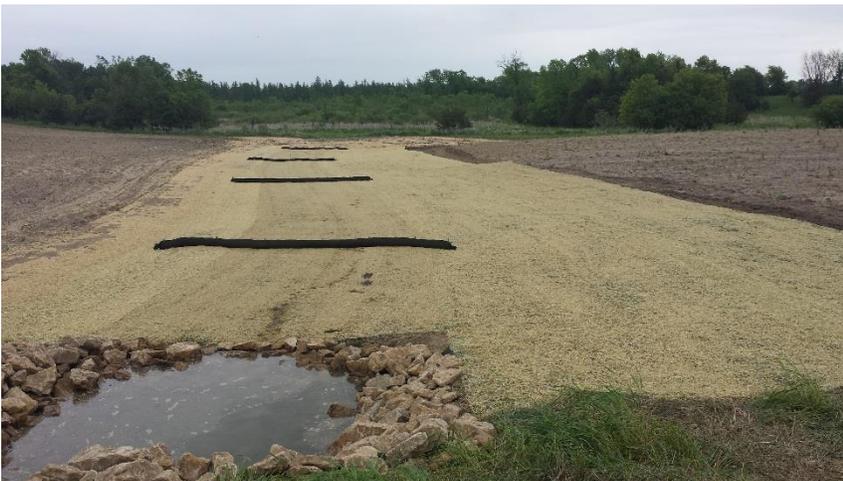
Two stabilization practices were installed at two different locations. In one field, a culvert allowed water to enter the field at a concentrated location, causing erosion across the field as it flowed to an adjacent wetland. At the culvert outlet, a rock bowl was installed to help dissipate energy. A grassed waterway was installed from the culvert to the wetland, giving water a place to flow that was well protected so that erosion would no longer occur.

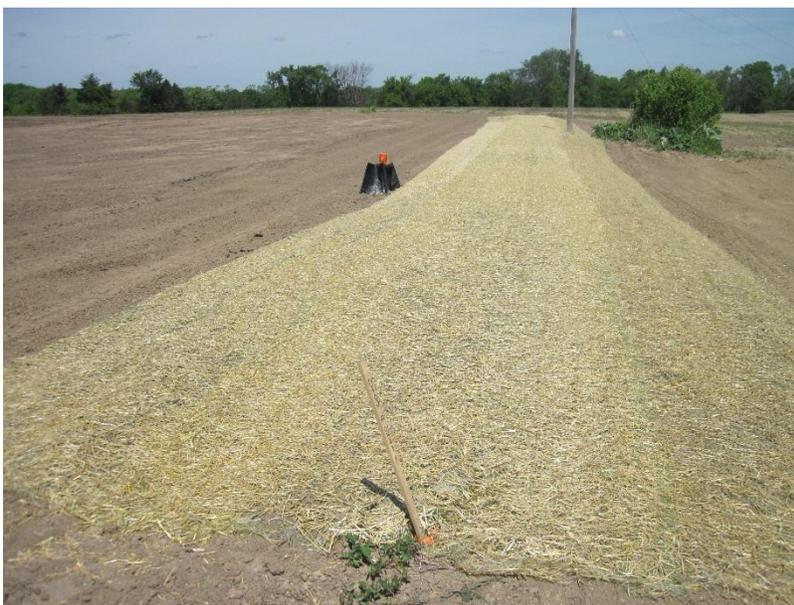
On a second field, a gully had formed as water flowed through the agricultural field. In this case, a water and sediment control basin was installed to temporarily hold back water. A perforated outlet pipe allows water to slowly drain to a protected outlet location.
