# LOREN'S PARK—CENTER CITY

## VEGETATED SWALE AND RAIN GARDEN

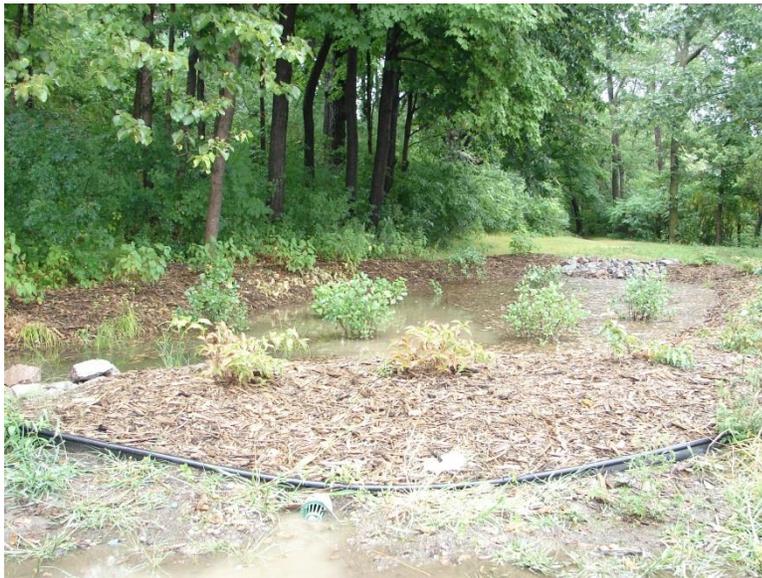
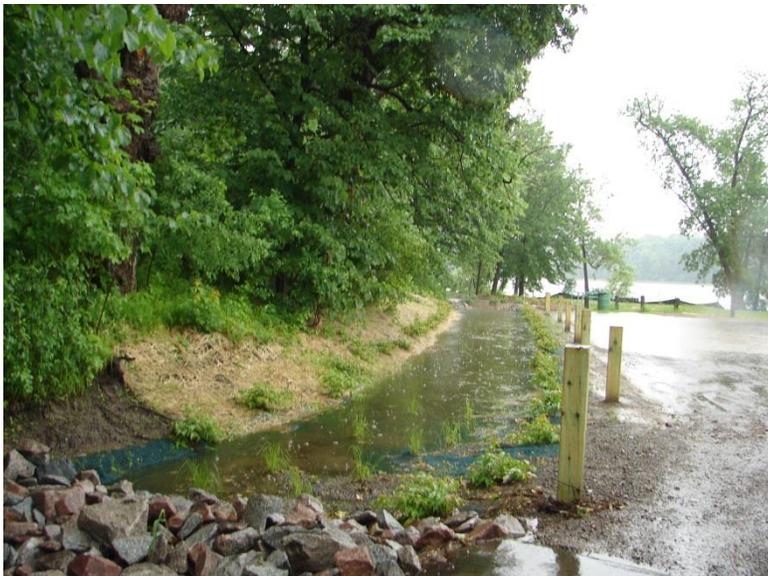
To correct the gully, the City of Center City paved the driveway and tipped it to the inside of the slope. The runoff collects along the inside curve of the road, where a curb guides it into a pretreatment chamber. The chamber collects leaves, twigs, and sediment. The filtered water then enters a vegetated swale. If the swale fills up, water overflows into a rain garden that is planted with native shrubs.

The City of Center City had an ongoing erosion issue at the entrance to Loren's Park on Grand Avenue. The entrance to the park is on a steep slope and the gravel driveway continually washed out when it rained. It caused a gully down the hillside into South Center Lake.
